Your Inspection Report

2551 St-Denis
Montreal, QC

INSPECTION DATE:
Thursday, November 5, 2009

RE: Report No. 1170, v.2
2551 St-Denis
Montreal, QC

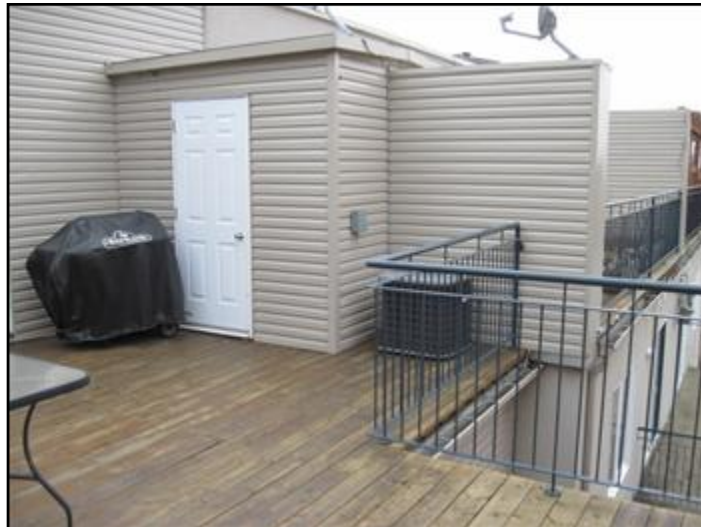
An examination of the wood deck surface indicates it is still in good condition, however the protective coating is beginning to wear off and needs to be refreshed within the next year.

Rear deck wood flooring

Care should be taken when applying new stain/sealer not to spill any material that could damage or affect the modified bitumen roof covering underneath.

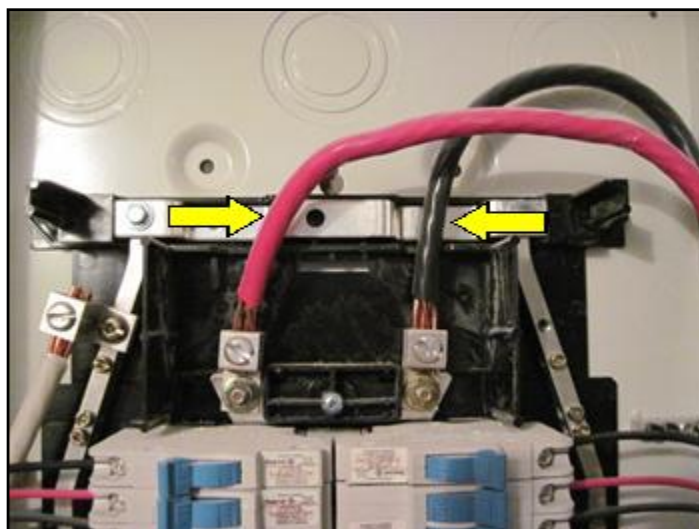
A 32 circuit panel normally is designed to handle a 150 amp entrance. The wire size coming into the panel appears to be 2AWG that is normally rated for 100 amps.

Service wires appear to be 2 AWG

However, only an electrician can determine how many additional circuits can be added without exceeding the maximum entrance capacity.

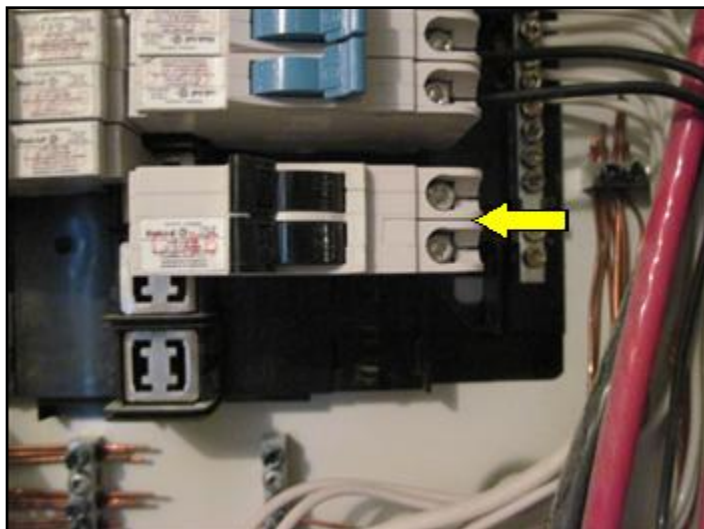
We did observe one breaker installed that is not in service and one set of wires that is not connected. These are possibly optional installations provided for other potential uses.

Breaker installed but not in use

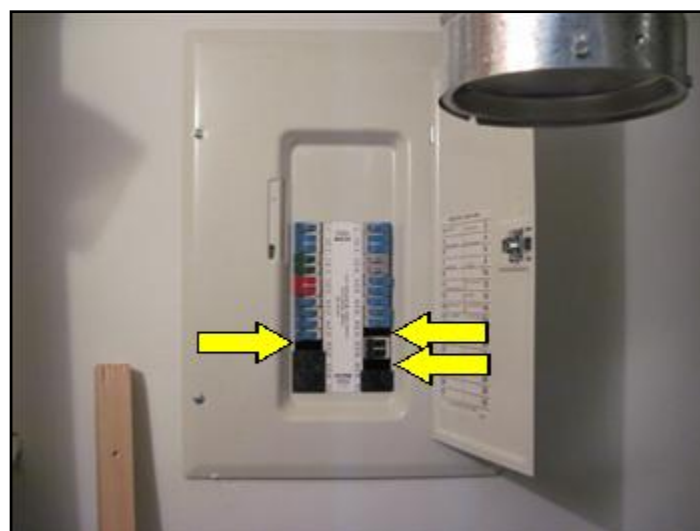
We observed some openings in the electrical panel cover where the normal plastic covers are missing. These should be covered as a safety measure since the main bus bars inside carry high electrical amperage.

Open areas in panel cover

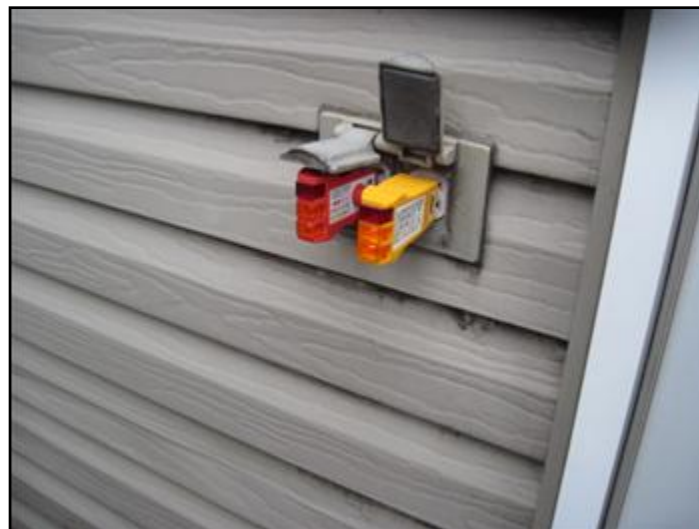
A test of the exterior electrical outlet on the exterior deck revealed the unit is not protected with a ground fault interrupter device.

Test indicates absence of protection

One should be installed for safety reasons.

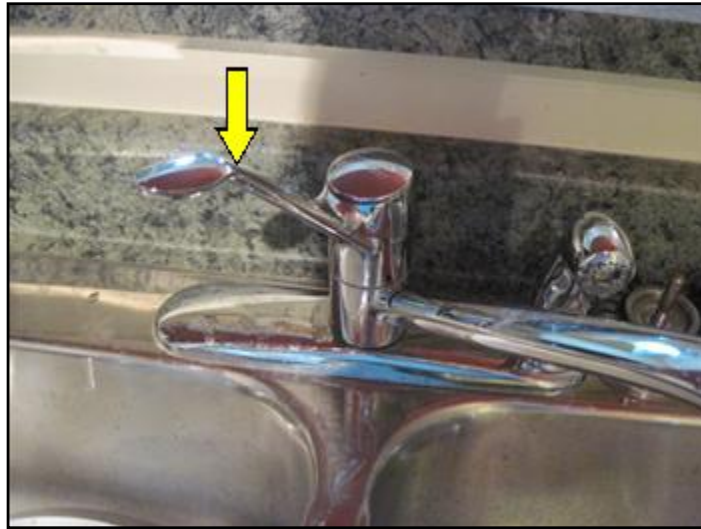
Noted the faucet handle for the kitchen sink has become loose.

Kitchen faucet handle loose

Tightening the screw inside the handle top will normally fix the problem.

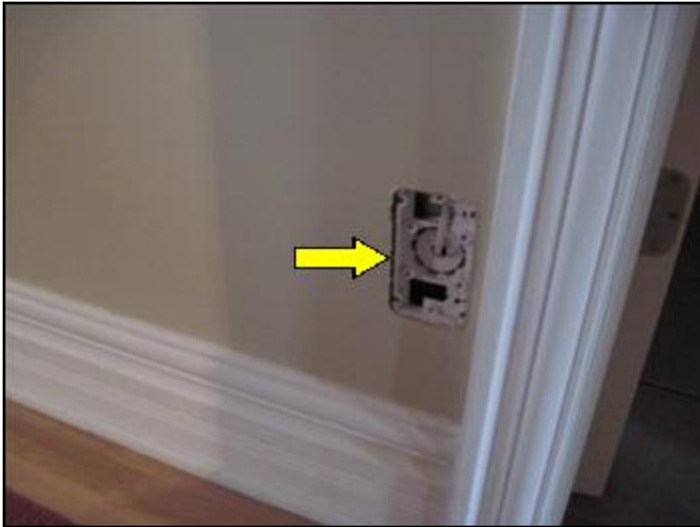
Hose connection for central vac missing cover

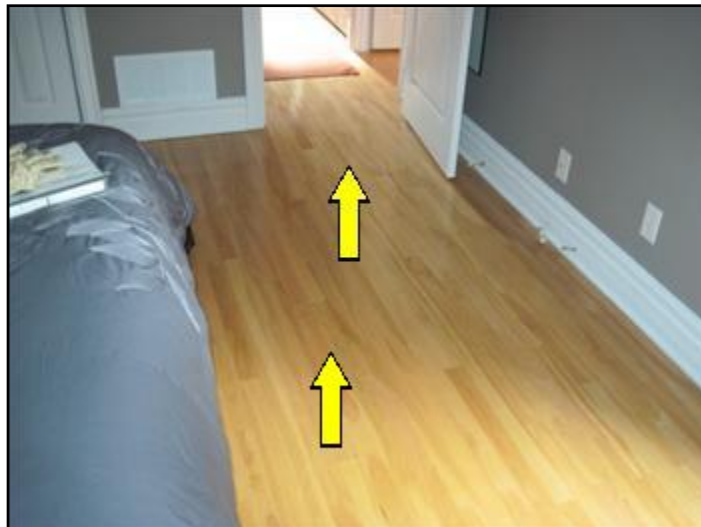
Observed the floors are not perfectly level particularly on the main floor area.

This may be caused by poor workmanship or the use of undersize materials at the time of construction or due to wood shrinkage or settlement occurring after construction.

The situation is not easily correctable, fortunately the variation is minimal and should not result in any loss of use.

Floor level dips towards hallway

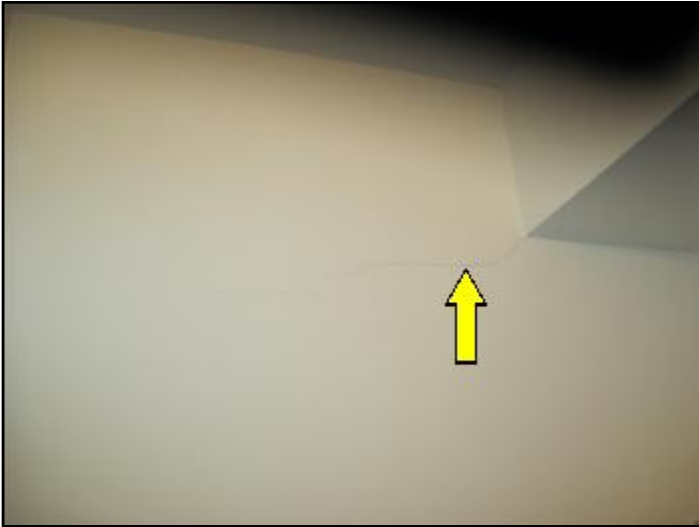
1- the master bedroom closet has one crack that appears to extend from a bulkhead about 24 inches. The crack is very narrow and should simply be repaired before re-painting.

Crack in master bedroom closet

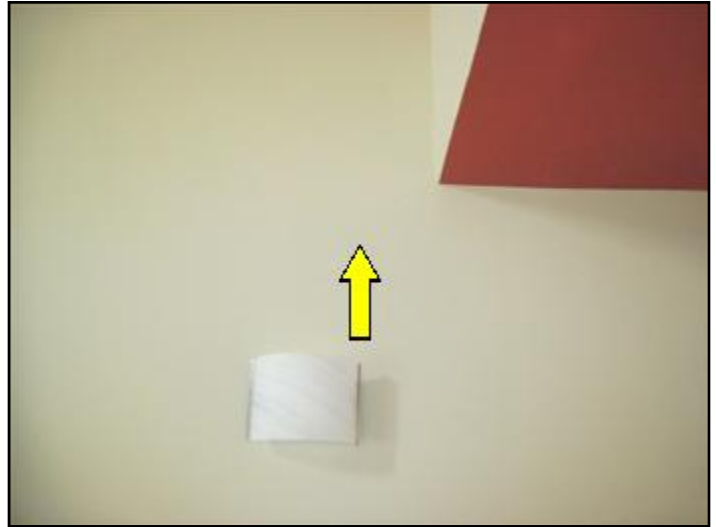
2- A second crack is visible in the left wall of the dining room. This area has been repaired to reinforce a lack of support for a beam located above. Based on the seller's declaration during the inspection the reinforcing was performed by the builder and movement has stopped. The newly formed crack is extremely small and should not pose a problem. Simply repair the wall surface before re-painting.

Crack below mezzanine on left wall

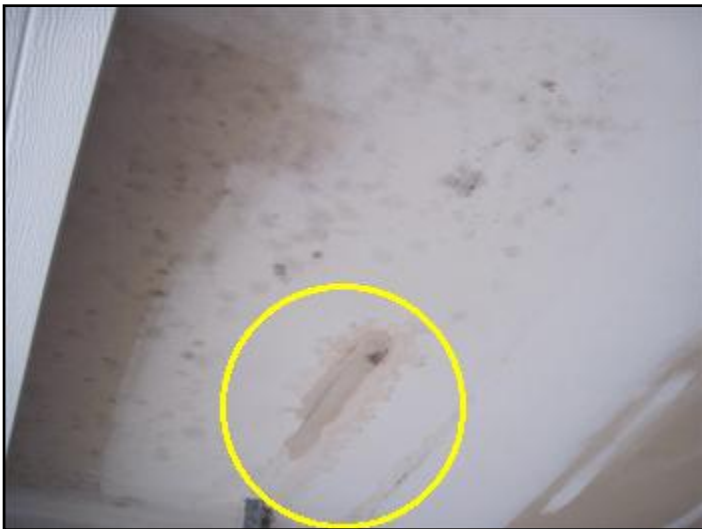
Observed water damage to the garage ceiling.

Water was still leaking at the time of inspection and appeared to be coming from the unit above.

Main water leak in garage ceiling

All of the affected drywall covering will need to be removed and replaced.

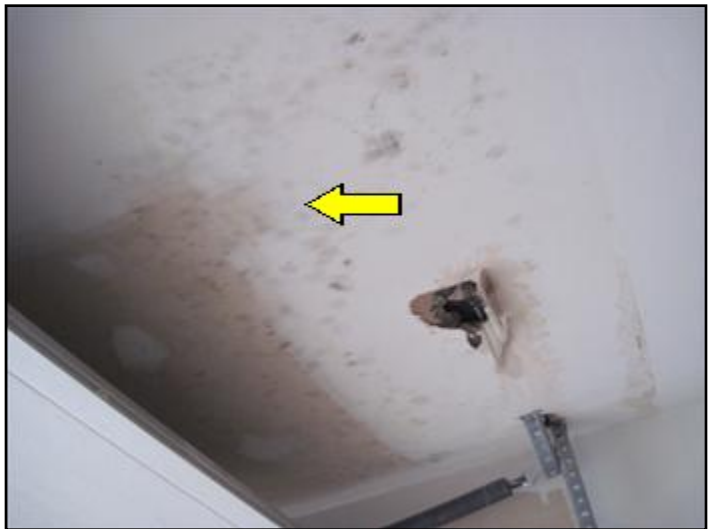
Presence of mould on garage ceiling

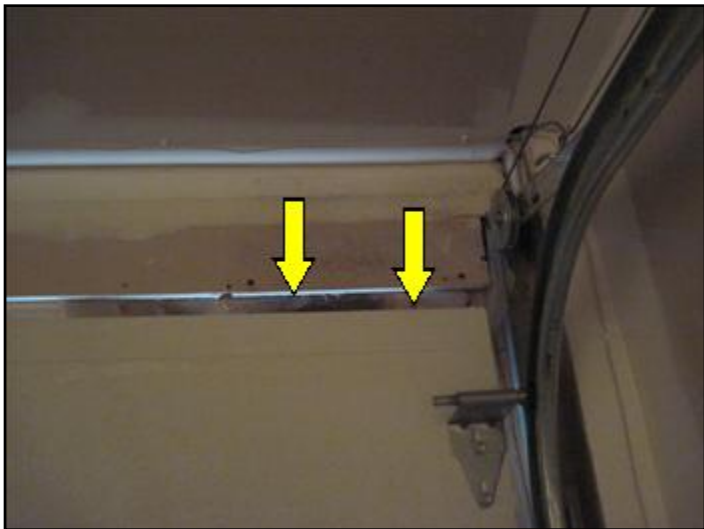
Water leak is traveling to top of garage door

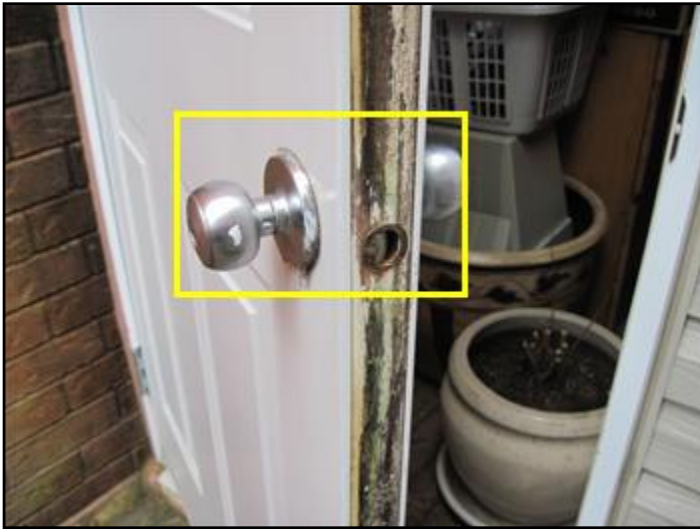
Noted the door latches for the rear exterior storage compartments are rusted and no longer functional. The compartments should be locked since they are accessible from the exterior.

Door latch jammed 2nd floor

The door knobs/latches should be replaced with devices designed for outdoor use and exposure to the elements.

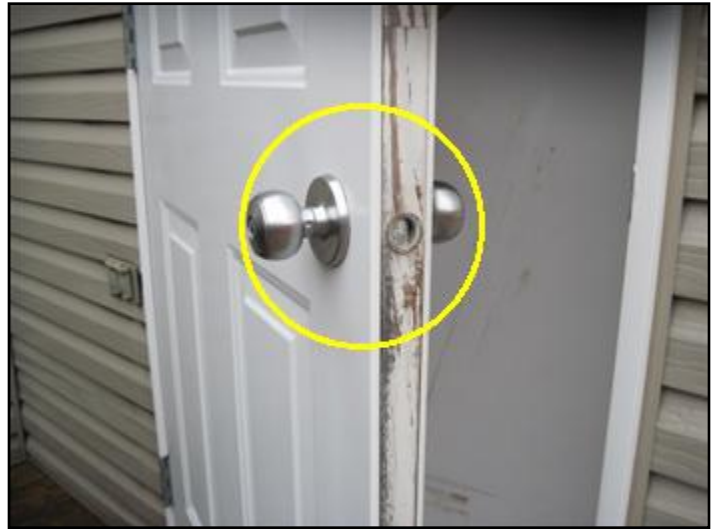
Door latch jammed main floor

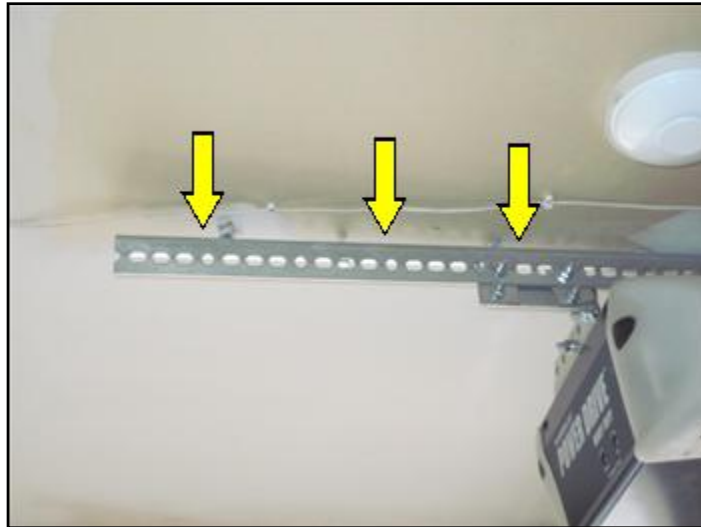
Condition: • Observed the garage door opener was not in service at the time of inspection.

The braces holding the opener have become detached and the until will need to be secured properly to the building structure before it can be used.

Braces have become detached on door opener
