Your Inspection Report

1252 King Avenue
Cote St-Luc, QC

INSPECTION DATE:
Friday, October 30, 2009

RE: Report No. 1168, v.4
1252 King Avenue
Cote St-Luc, QC

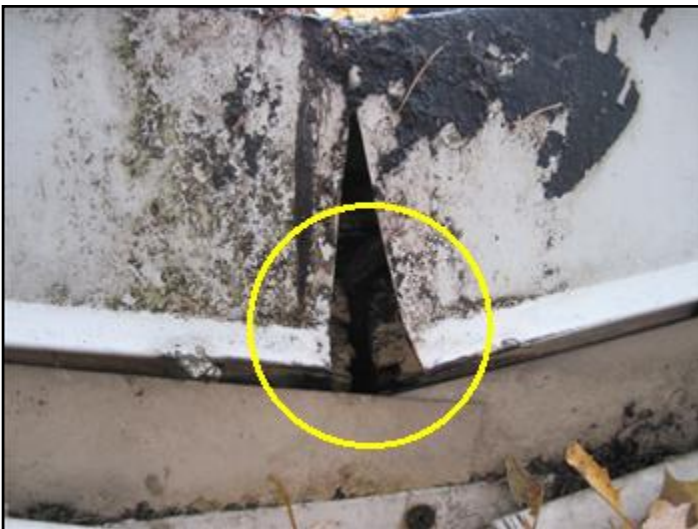
Noted a poor drip edge flashing installation at the rear,

This is allowing water to come into contact with the wood fascia and there is evidence the wood has begun to rot.

Water penetrating wood exposed

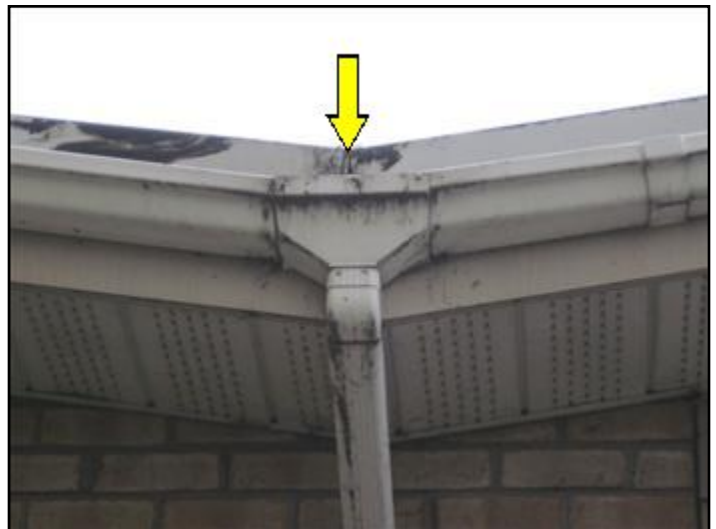
Exposed fascia on rear section

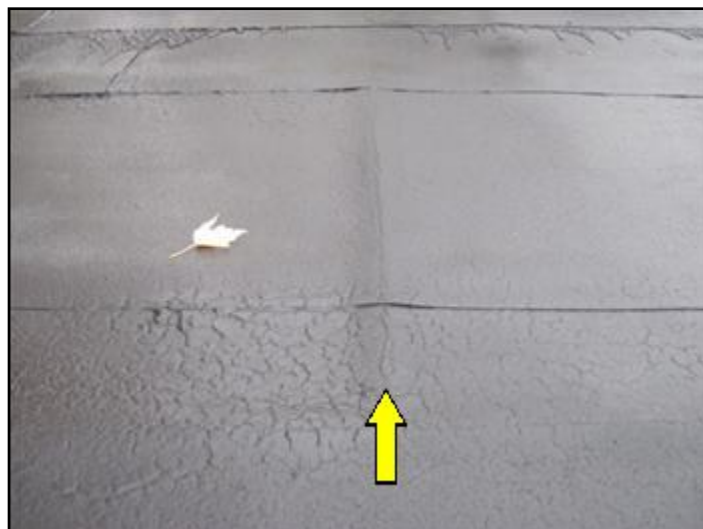
The portion of membrane that has not been coated suggests the original membrane is modified bitumen with ceramic granules to protect against UV damage.

Ridging visible

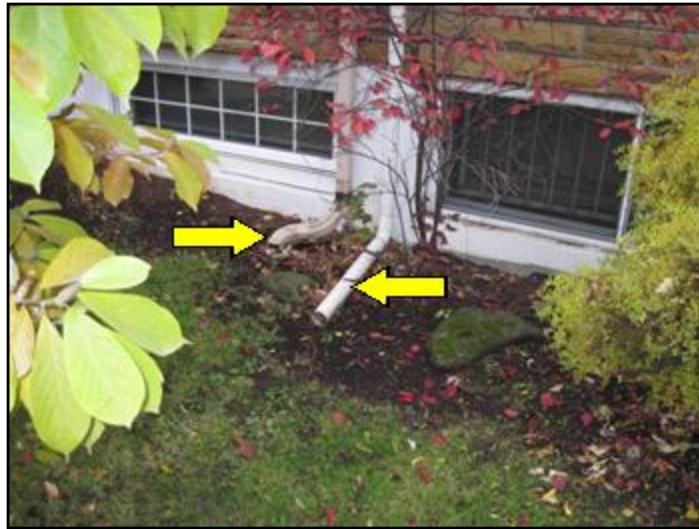
Observed two gutter downspouts near the median wall in front that should be extended to move water away from the foundation.

Downspouts in front too close to foundation

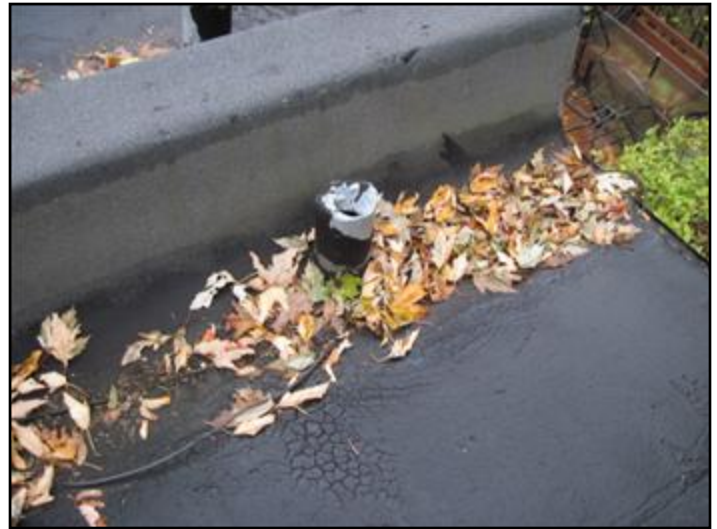
Observed a roof drain that was completely clogged at the rear of the building.

Debris accumulation on roof

Recommend cleaning the roof and drain from all debris at least twice a year.

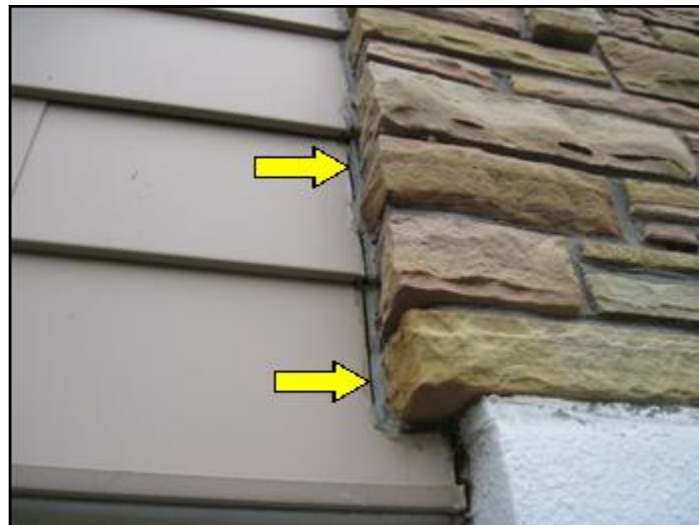
Observed some areas where the caulking has dried and no longer provides an effective seal.

Caulking joint due for replacement front wall

All joints should be examined and replaced as necessary as part of normal home maintenance.

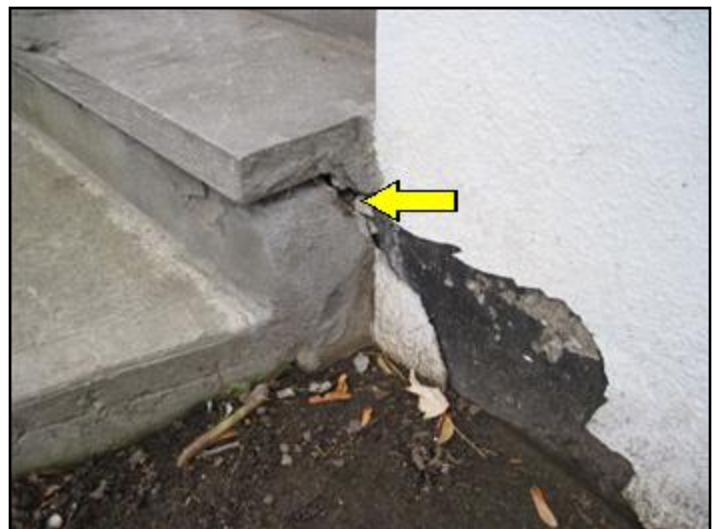
Observed some settlement of the front walkway.

This has caused a gap to open up between the walkway and the stairs.

Settlement has caused a gap to open

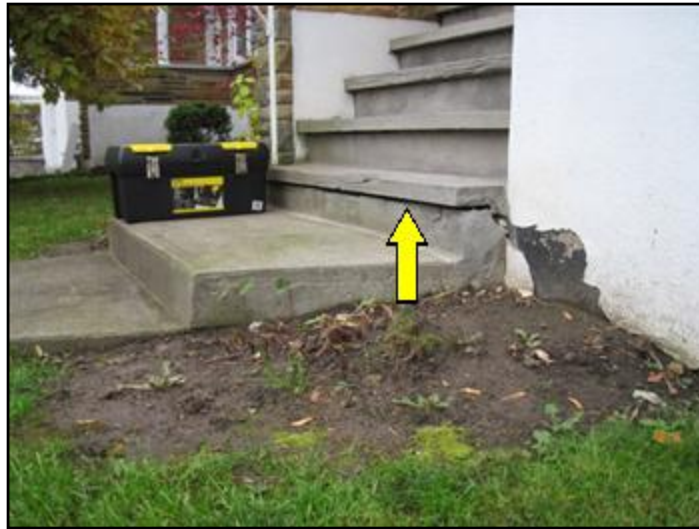
Settlement has caused a gap to open

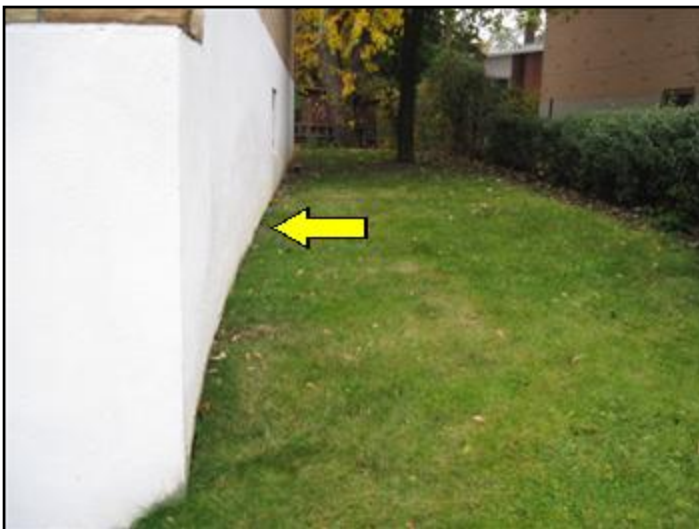
Observed the lot grading around the house favours water being drawn towards the foundations. This can cause high humidity, water infiltration and mould problems in the basement over time. See recommended guidelines for proper lot grading.

Lot sloping towards foundation on right side

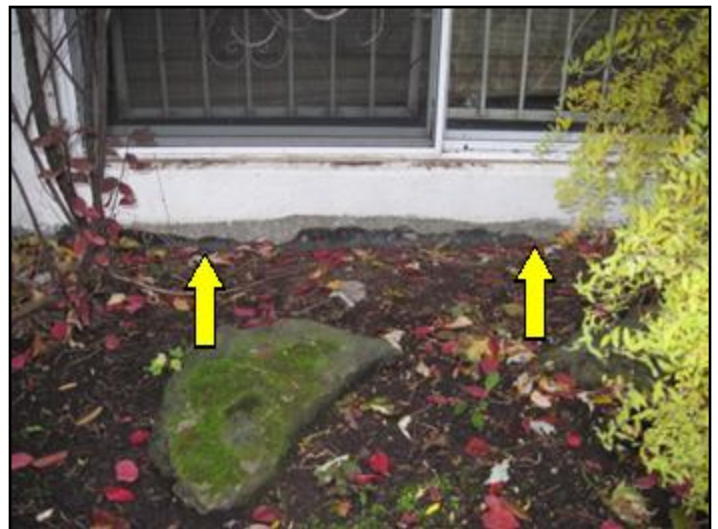
Lot sloping toward foundation in front

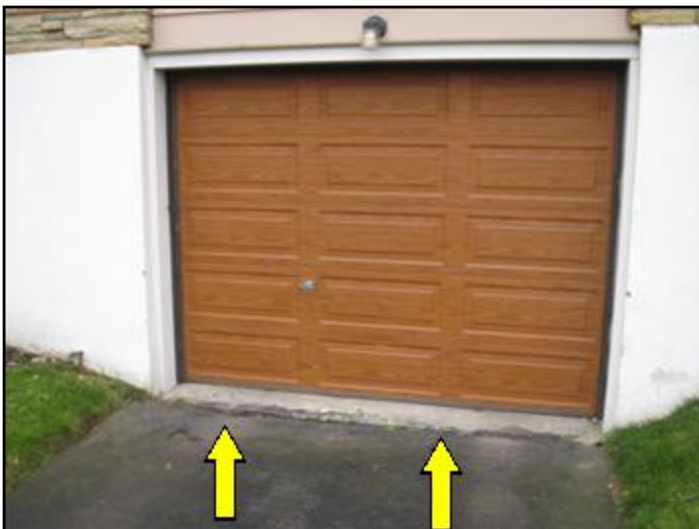
Noted the driveway slope is such that water is being drawn toward the end of the garage door.

This area has settled and is causing water to pool and sink into the opening between the asphalt and the concrete slab. Water saturation can cause damage to the slab through frost heaving.

Slope towards garage door

Recommend correcting the slope and sealing the gap in the interim until the driveway is redone.

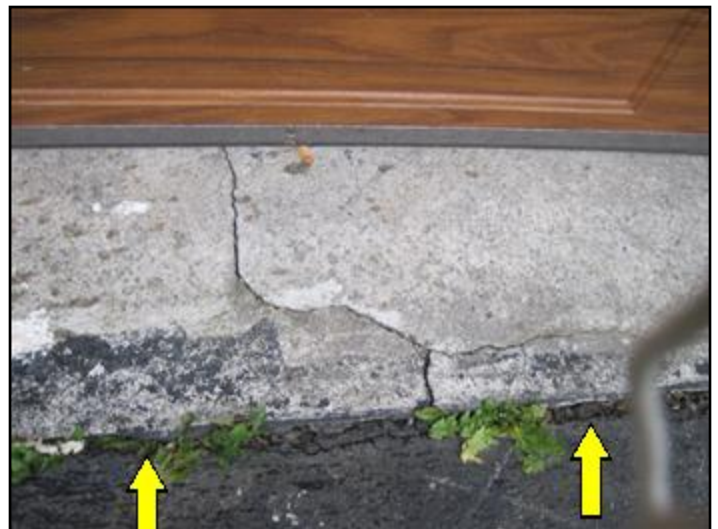
Damage to concrete

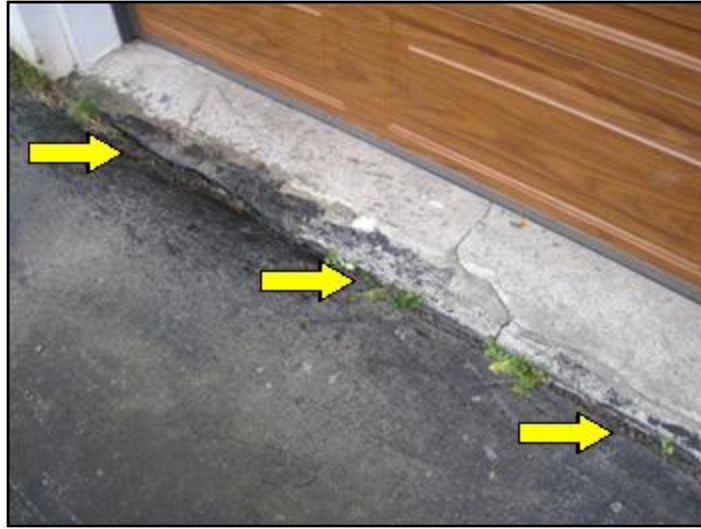
Improper slope causing water to accumulate

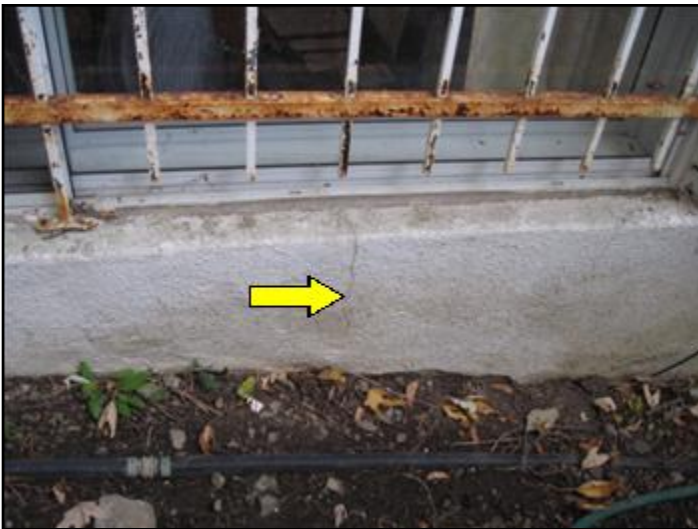
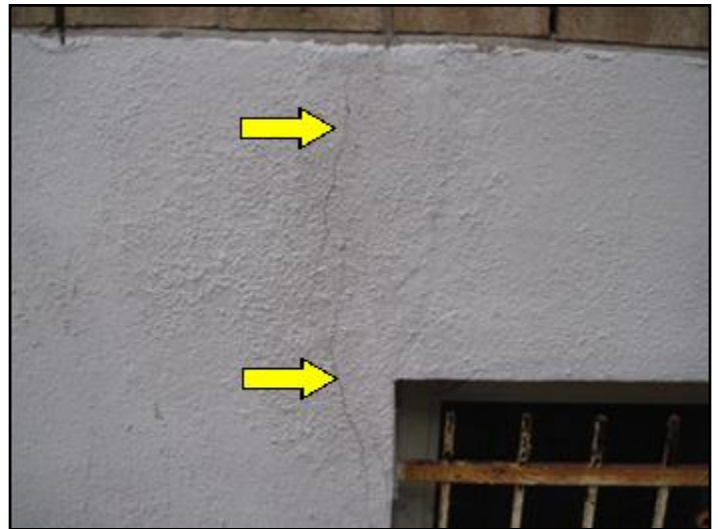
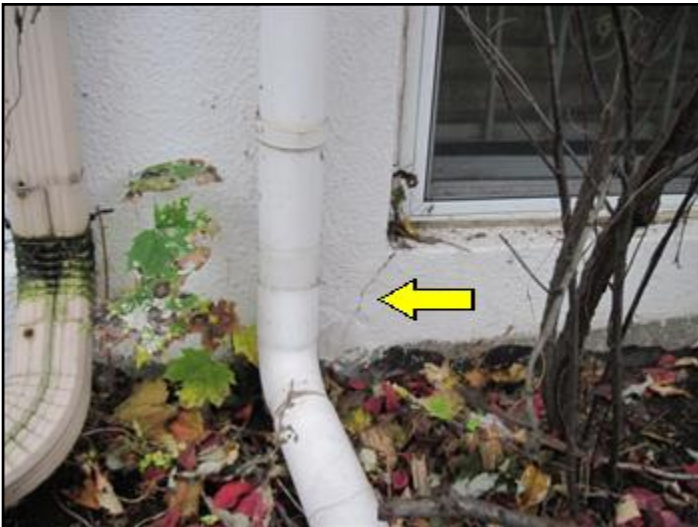
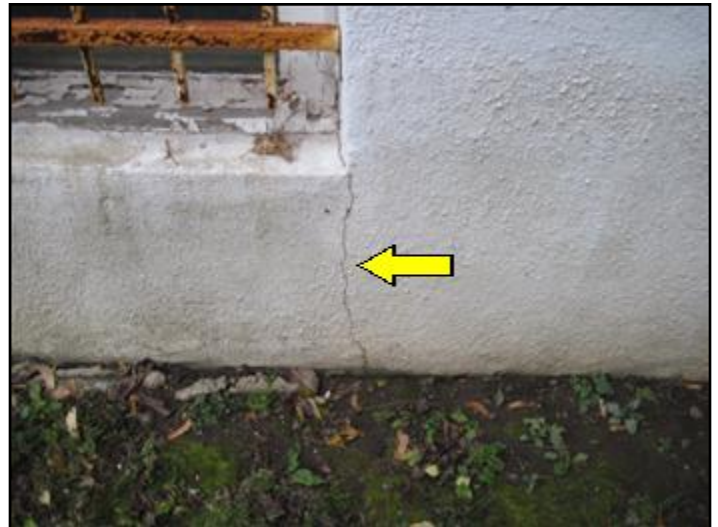
Noted a total of 5 cracks in the foundation.

Crack rear wall

Crack right wall

Crack front wall

Recommend sealing the other cracks to reduce the risk of water infiltration into the basement.

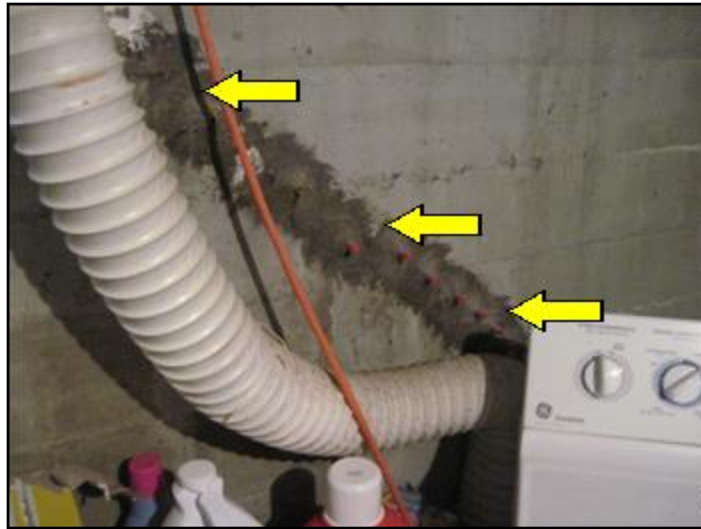
One of the cracks was visible from the interior in the furnace room and we were able to see evidence of an epoxy injection repair.

Epoxy injection repair rear wall

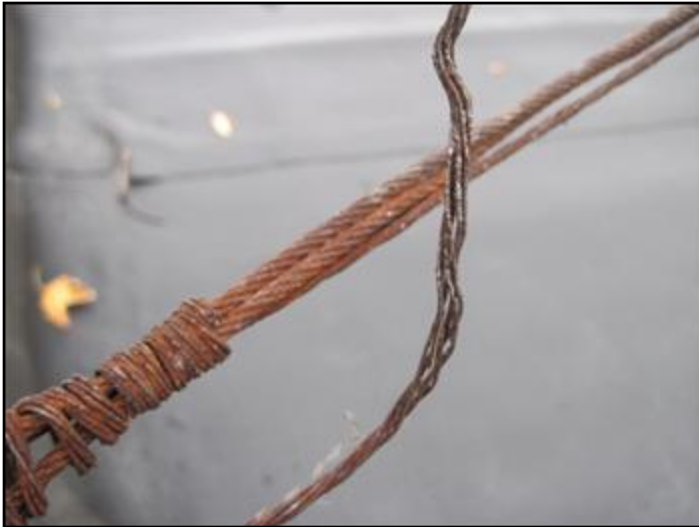
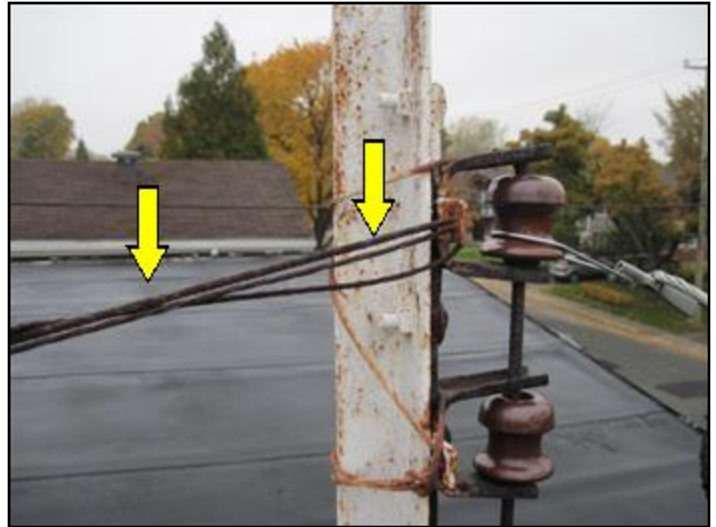
The steel cable is corroded and its attachment should be monitored and improved as necessary.

Steel cable is corroded

Steel cable holding back electrical mast

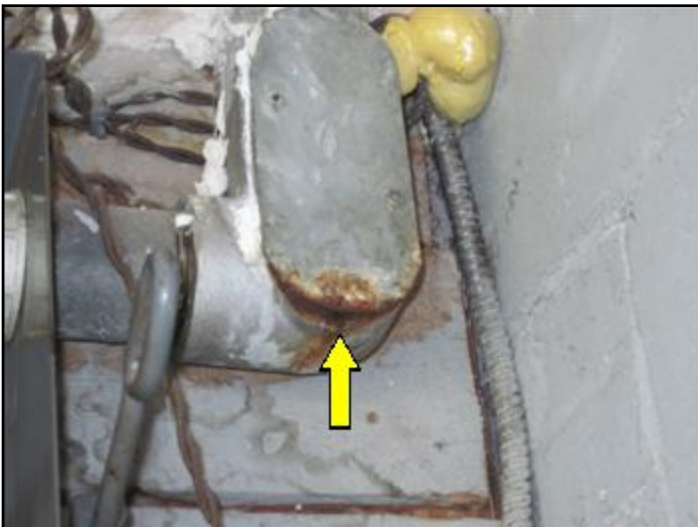
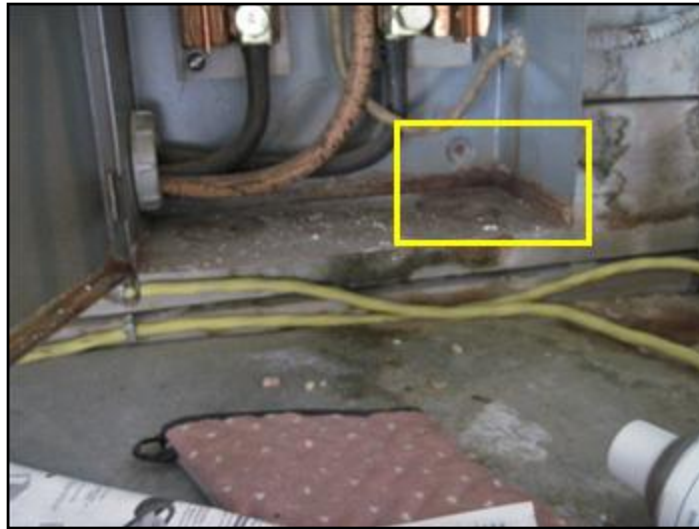
Observed traces of corrosion in the electrical conduit and main disconnect box.

Suspect there may have been water infiltration from the masthead on the roof inside the conduit at some point.

Corrosion at base of electrical conduit

Corrosion inside main disconnect box

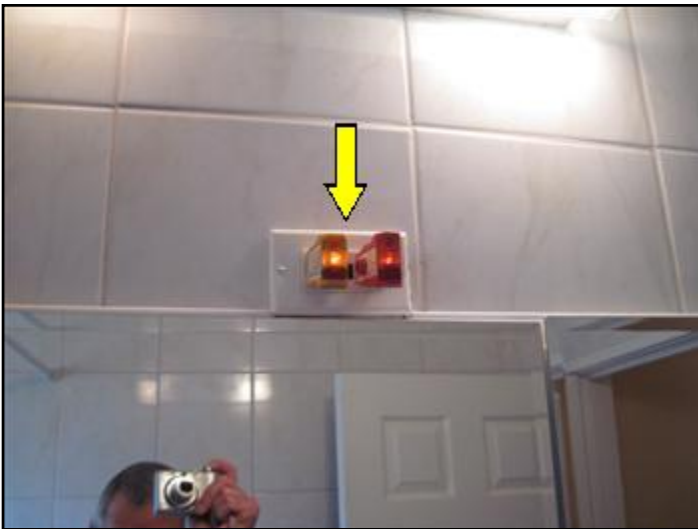
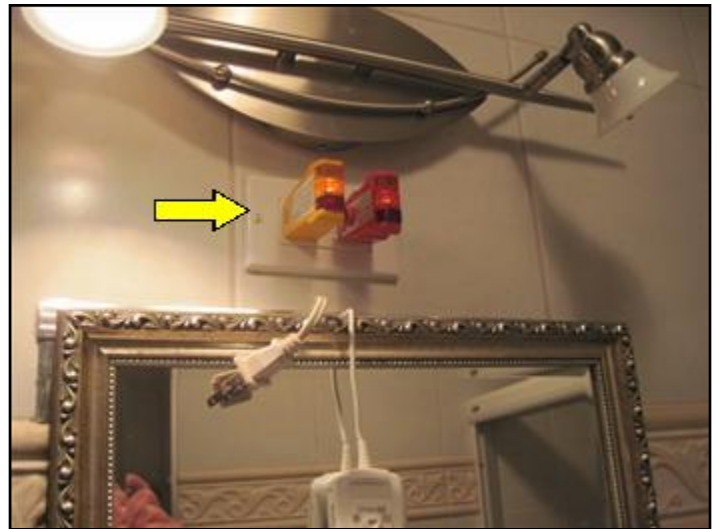
The GFI devices in the bathrooms failed to trip when put under test.

GFI under test failed to trip

Recommend an electrician verify the devices and their installation.

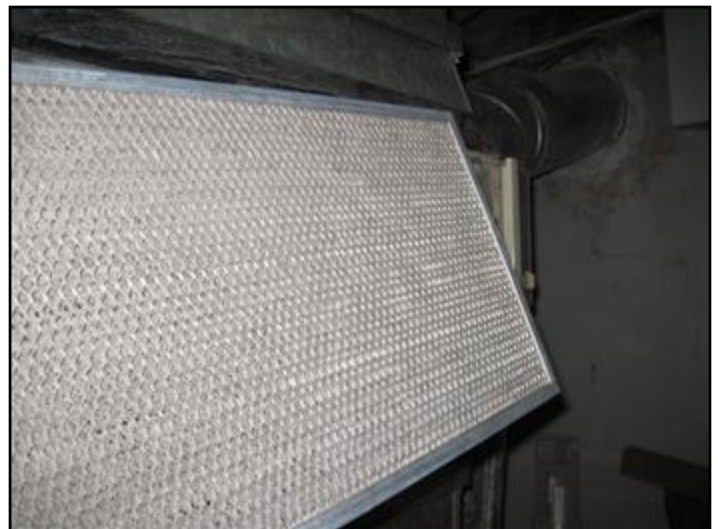
Pre-filter is clogged

Recommend cleaning the electronic air filter every month for optimal performance or using high efficiency disposable air filters and replacing them every three months.

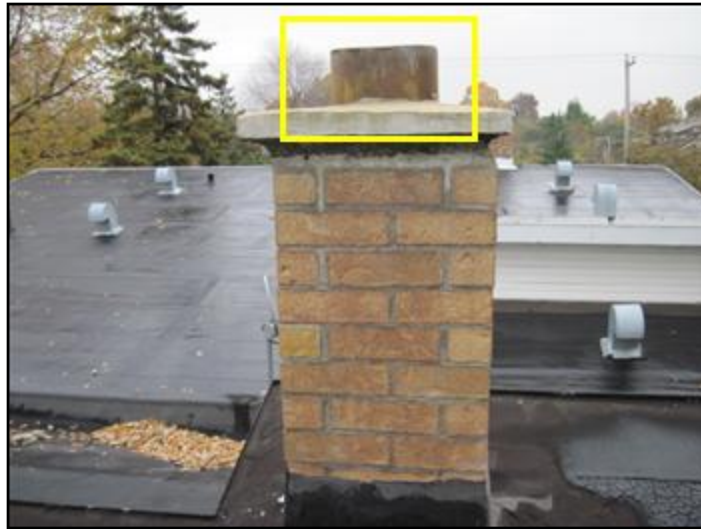
Noted the absence of a chimney cap on the furnace chimney flue.

Also found traces of water infiltration at the base of the chimney clean-out due to the lack of a cap.

Chimney cap missing

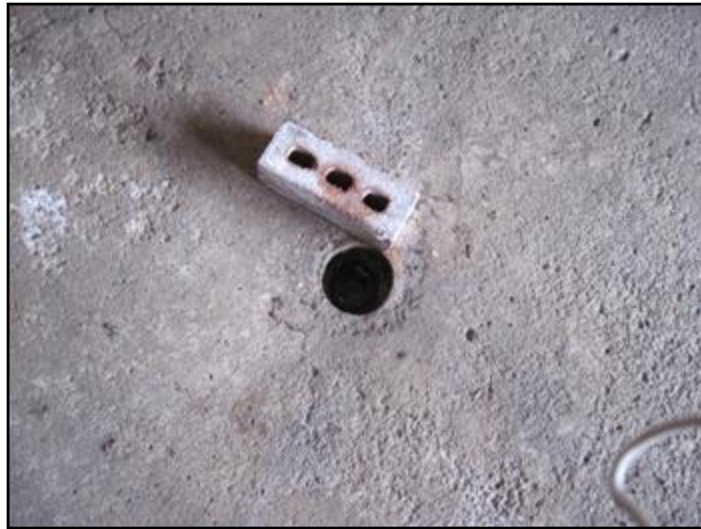
Condition: • Noted the garage is equipped with a conventional floor drain which can easily become clogged with sediment.

Garage floor drain

Recommend the installation of a floor drain designed specifically for garage use with a catch basin and reverse trap.

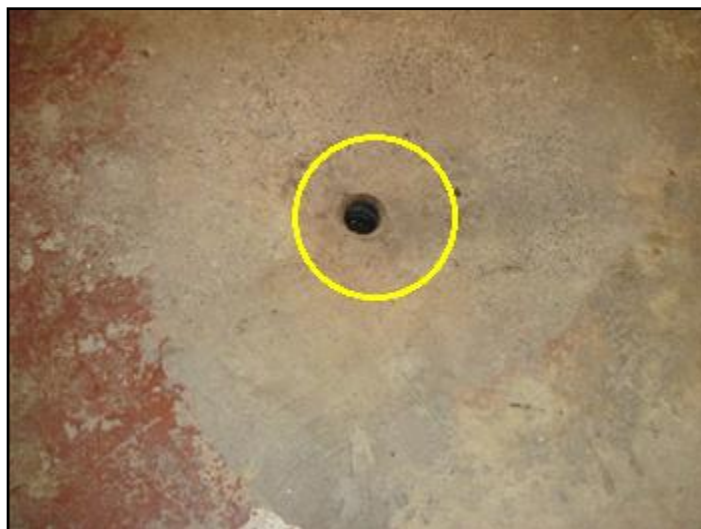
Grate missing on basement floor drain

Recommend the installation of a grate on the basement floor drain.

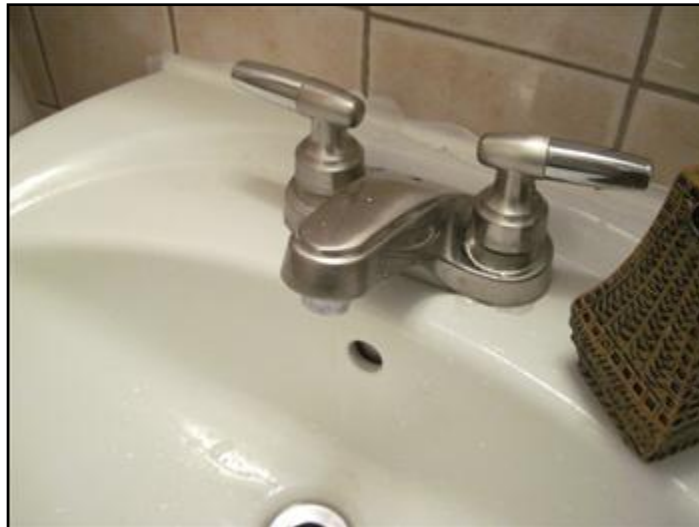
Observed the sink faucet in the basement bathroom is leaking.

Basement bathroom faucet leaks

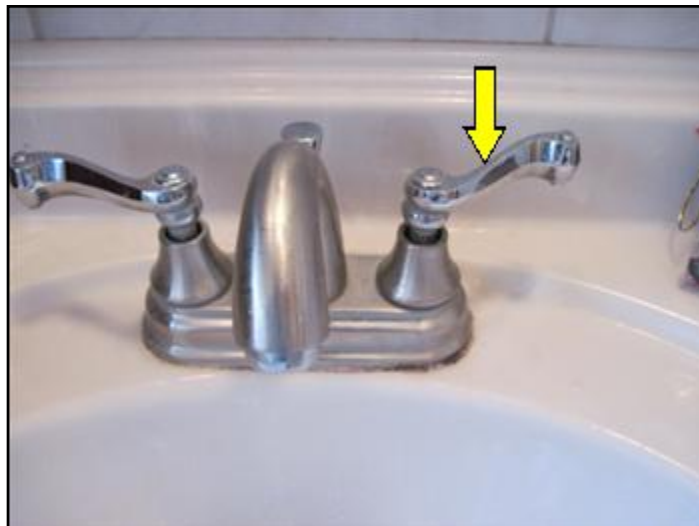
Observed the cold water faucet handle on the sink faucet is not properly secured.

Faucet handle not properly attached

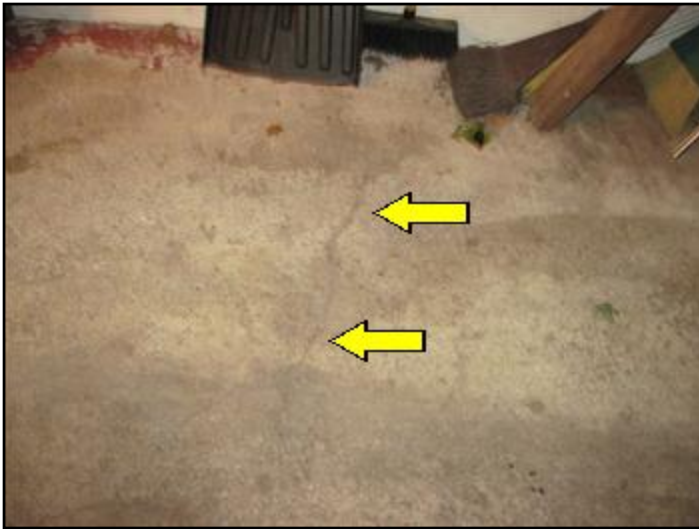
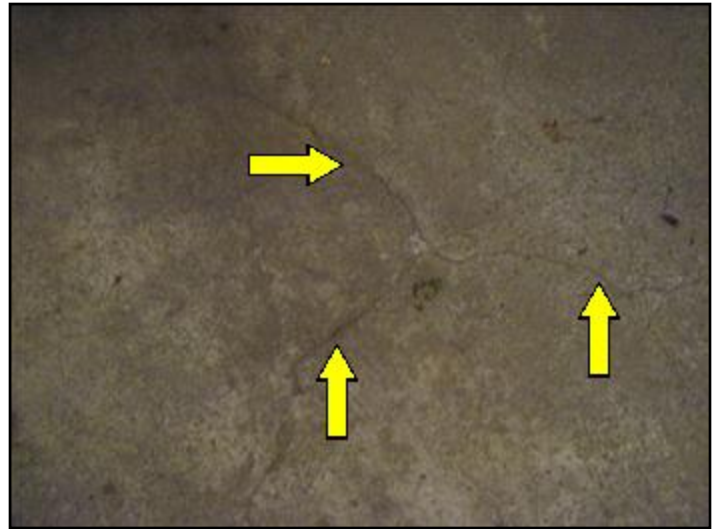
Cracks in garage floor slab

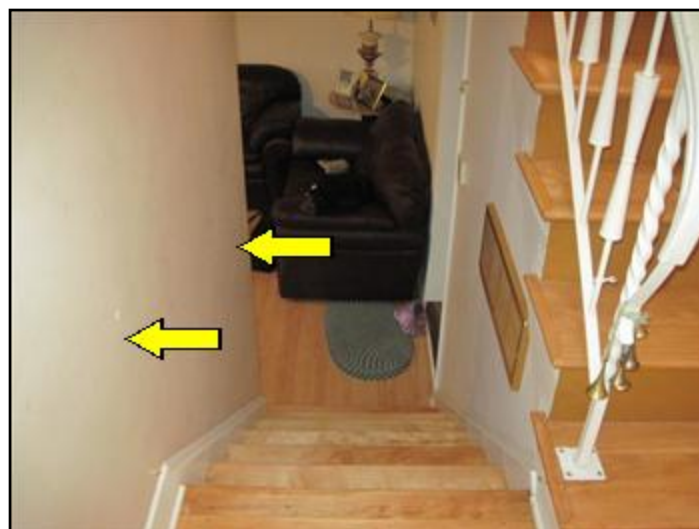
Noted a handrail is missing in one of the basement staircases.

Handrail missing
