# Your Inspection Report

6071-6075 Buckingham Ave  
Mount Royal, QC

RE: Report No. 1163, v.3  
6071-6075 Buckingham Ave  
Mount Royal, QC

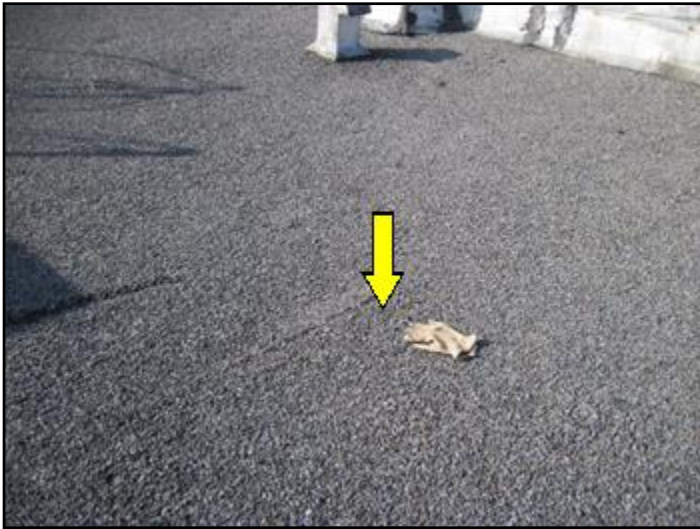
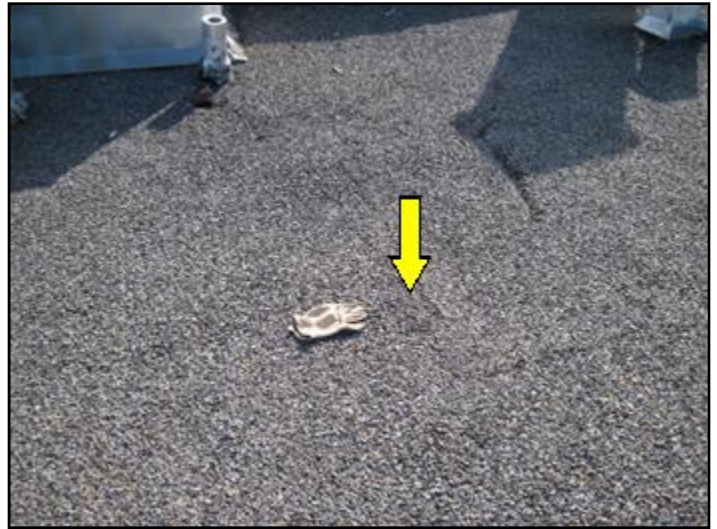
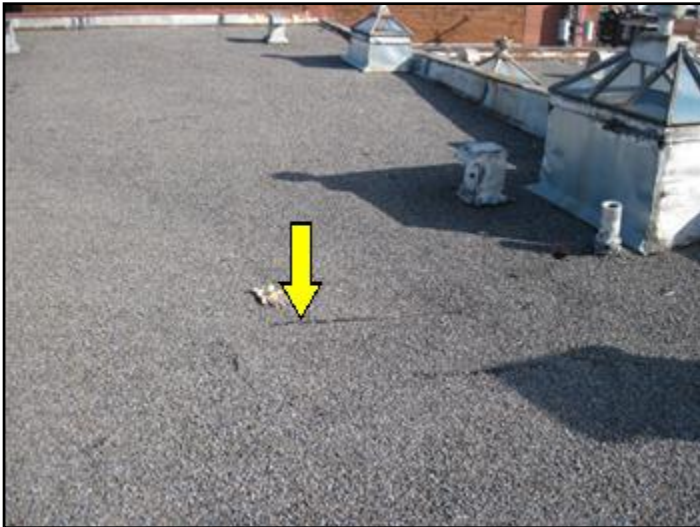
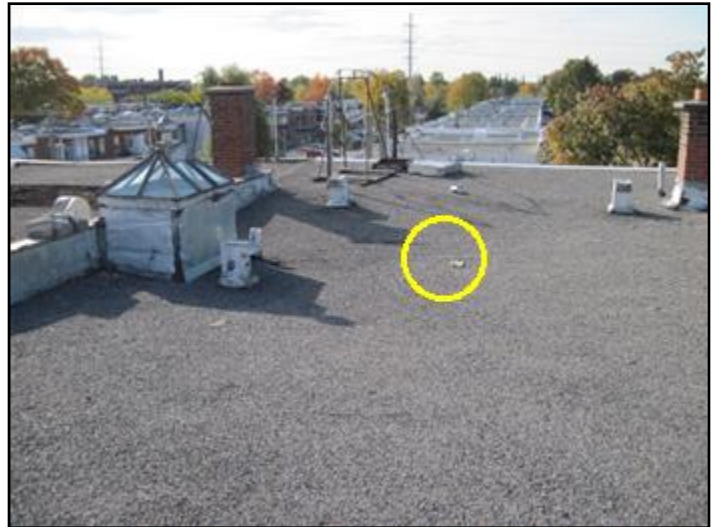
Observed a blister in the roof membrane around the mid rear section.

This area can become a high risk water infiltration area should the blister puncture. We also noticed what appears to be the possible outline of a prior repair in that area.

*Location of blister on roof*

Recommend having a roofing company perform an evaluation and needed repair.

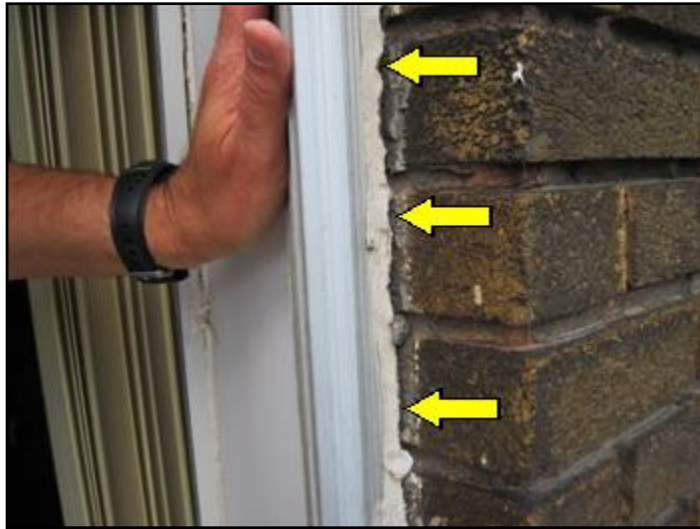
The exterior window sealants are in need of replacement.

*Caulking has shrunk leaving an open gap*

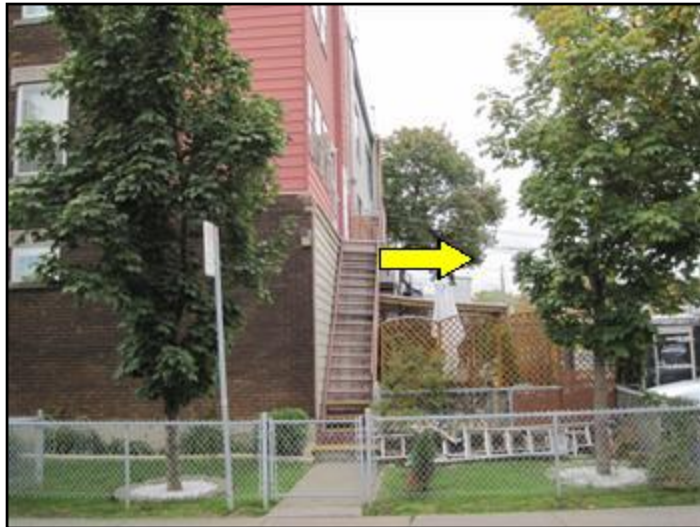
**Condition:** • Noted the rear exterior steel staircase is leaning to the right. Because the balcony structure and attachment to the building are not visible it is impossible to determine if the balcony has moved and shifted the staircase along with it.

*Rear staircase leaning to the right*

Further evaluation of the balcony structure is recommended to obtain a proper diagnosis.

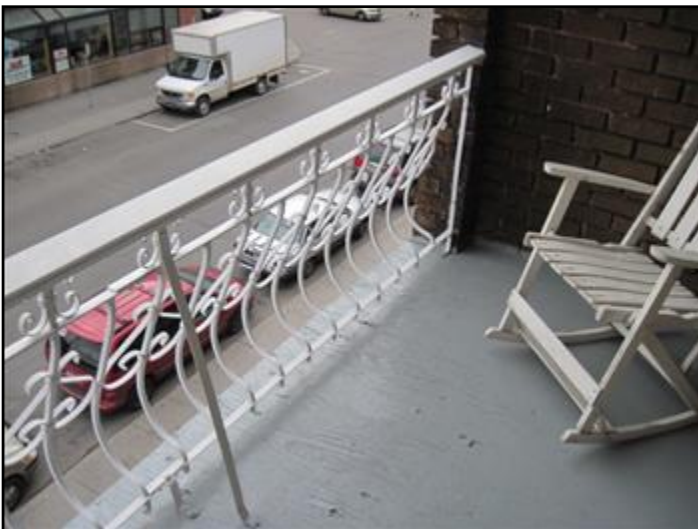
Front balcony guardrail's too low

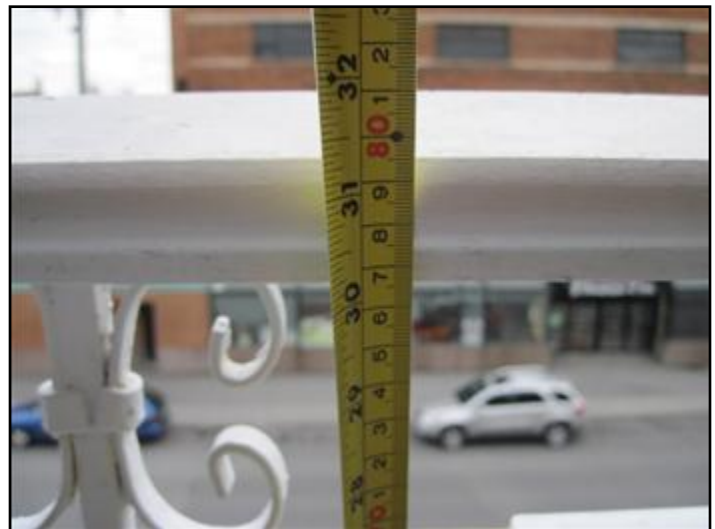
Guardrail's under 32" high

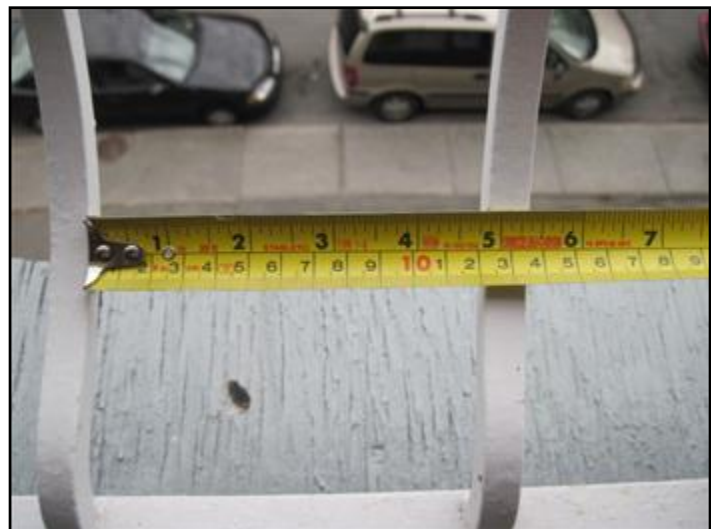
Noted the spacing between the guardrail bars exceeds 4" and presents a safety hazard for children.

Spacing between bars exceeds 4"

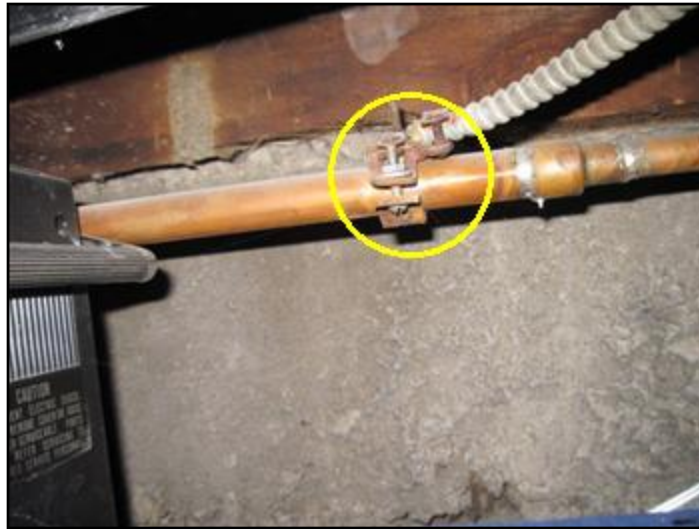
Noted the system ground which should be connected to the water main before the valve was absent.

Found a ground connection in the basement that is connected to a water pipe.

*Ground connection to water pipe in basement*

Recommend having an electrician verify the system ground installation and make the necessary corrections.

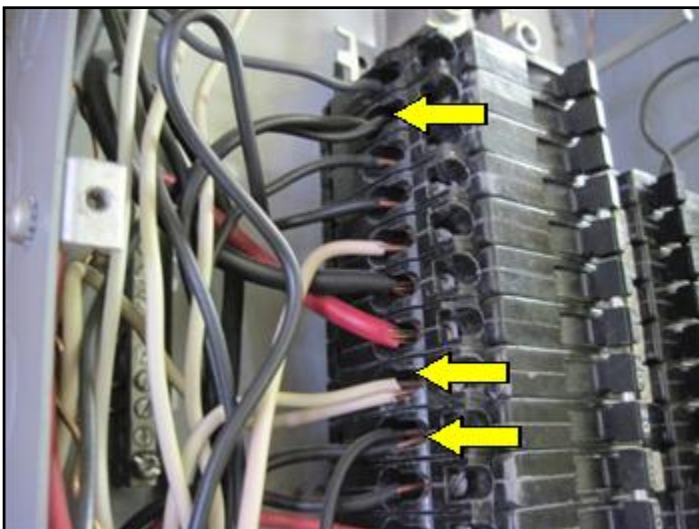
Observed double taps in the distribution panels of 5091 and 5093.

Double taps in panel 5093

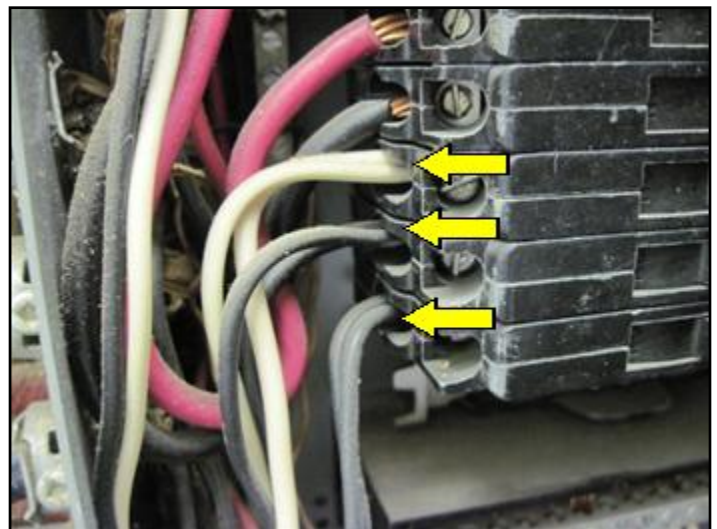
Double taps in panel 5091

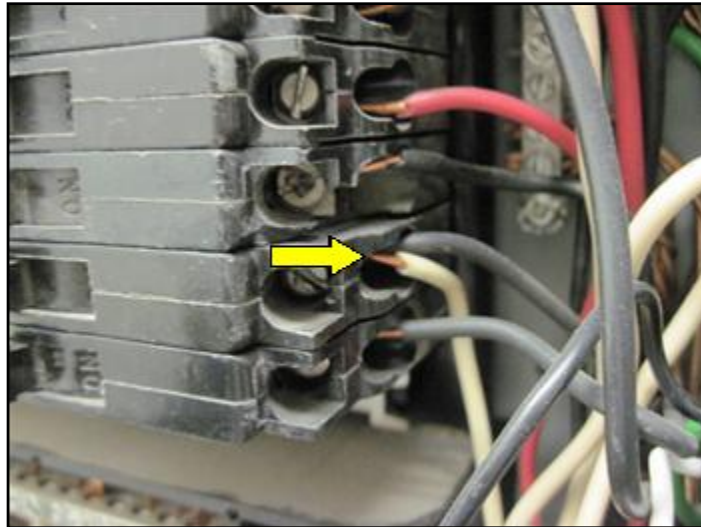
Double taps in panel 5091

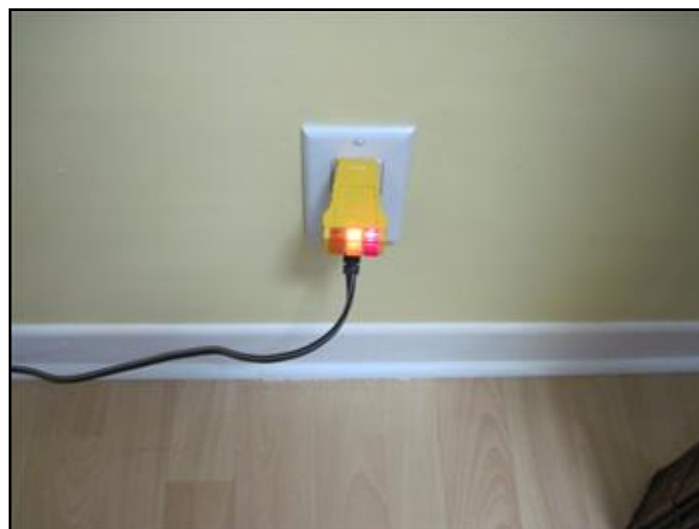
Detected a reversed polarity outlet during a test sample of the outlets in the building. Recommend correcting for maximum safety.

*Reversed polarity on bedroom outlet 5089*

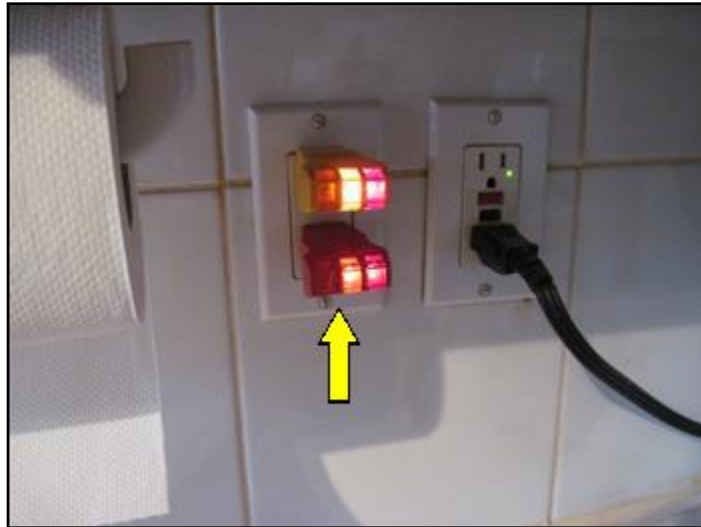
A test of the GFI devices in the kitchen revealed one is defective,

*GFI device faulty*

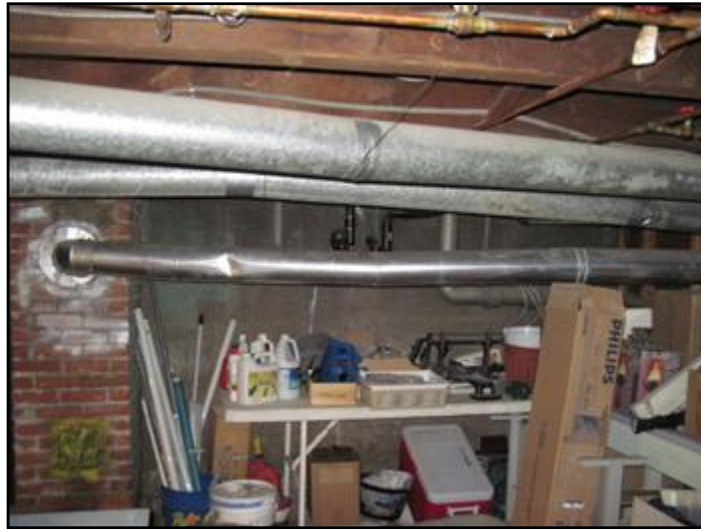
Observed the gas furnace combustion exhaust pipe is quite long, does not have a very good slope and actually dips a bit before going up into the masonry chimney.

*Vent slope questionable*

Recommend having a monoxide gas detector installed in the basement and having a heating specialist evaluate if the pipe slope can be improved.

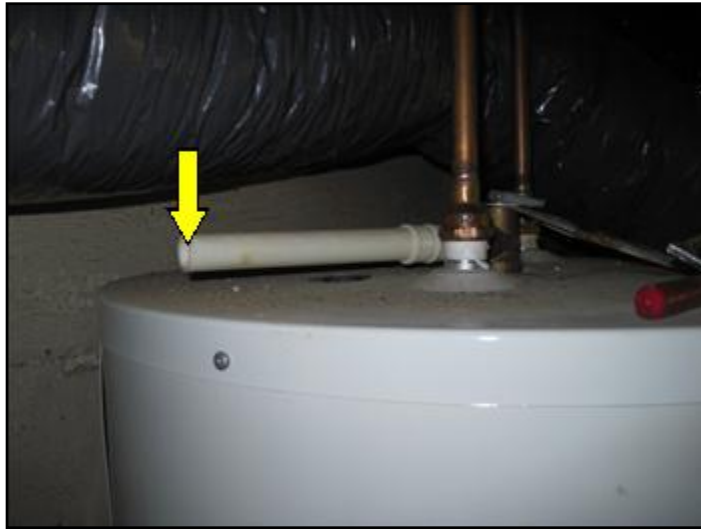
Noted the pressure safety release valve for the water heater of unit 5089 is too short.

This should be repaired for safety reasons.

*Discharge tube too short*

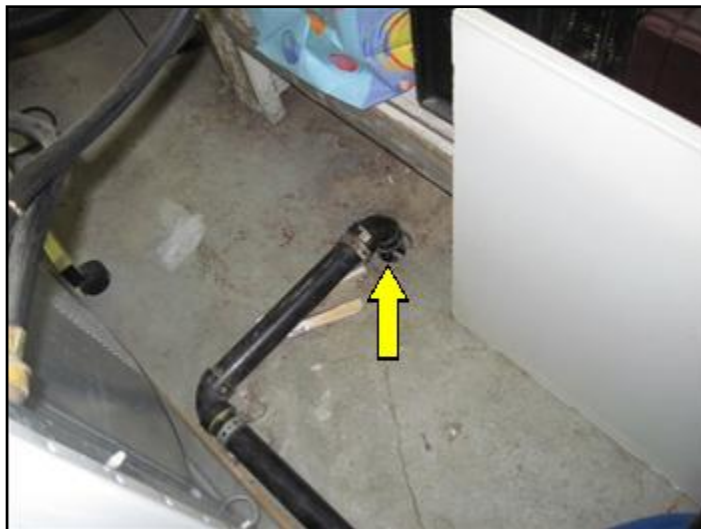
**Condition:** • Noted the laundry tub drain pipe installation is not properly connected to the sewage system. Instead the drain pipe is simply brought above the floor drain.

*Laundry tub drain pipe over floor drain*

Recommend a proper plumbing connection be made.

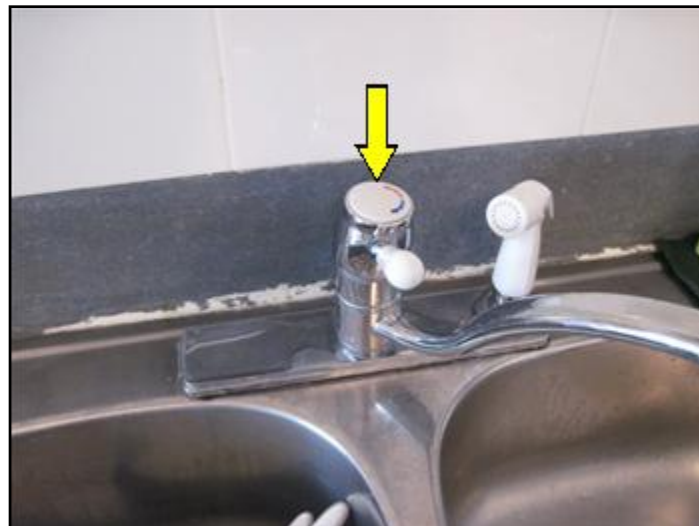
Noted the control arm on the kitchen faucet is loose and difficult to operate. Suggest repairing or replacing the unit.

*Loose control arm*

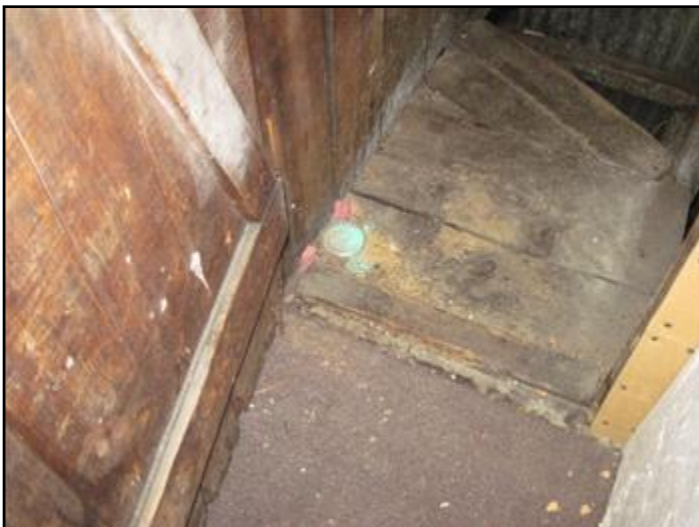
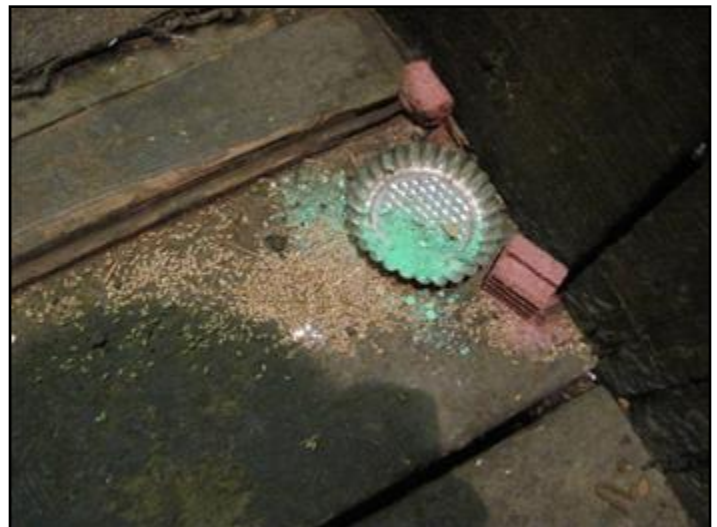
- Observed the presence of rodent bait/poison in the utility room of unit 5093. This area is partially outside the building envelope as it communicates directly with the rear fire escape. We did not find any presence of bait or other signs of rodent presence inside the unit.

Rodent bait trap utility room 5093

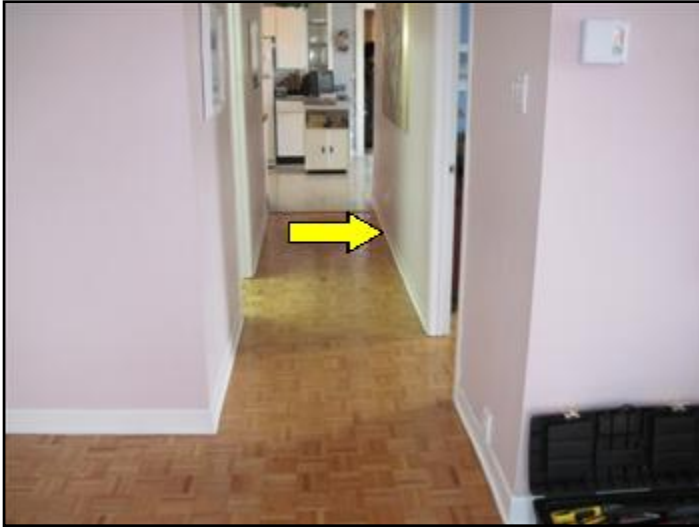
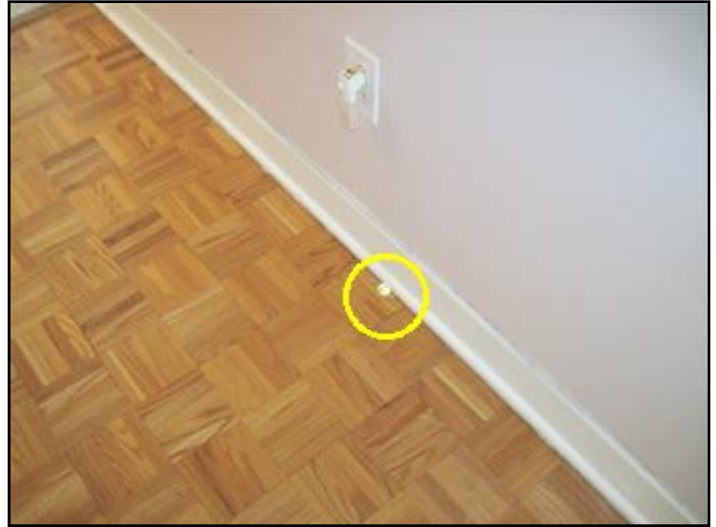
**Condition:** • Observed a visible drop in the floors towards the central part of the building.

Examination of the floor structure in the basement did not reveal any visible signs of the cause or any anomalies.

*Low point in 5093*

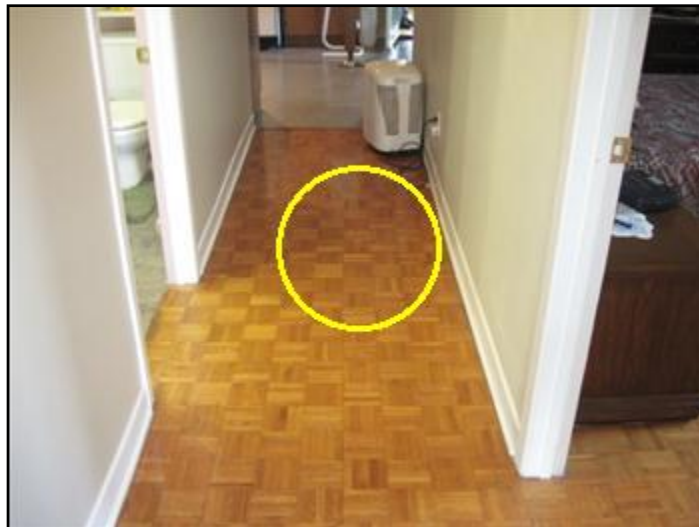
*Low pint in 5091*

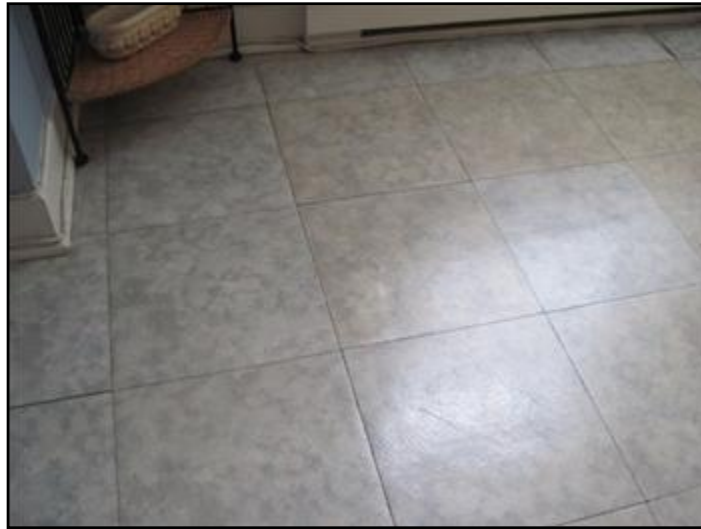
**Condition:** • The linoleum flooring is old and discoloured and is due for replacement.

*Discoloration of flooring tiles visible*

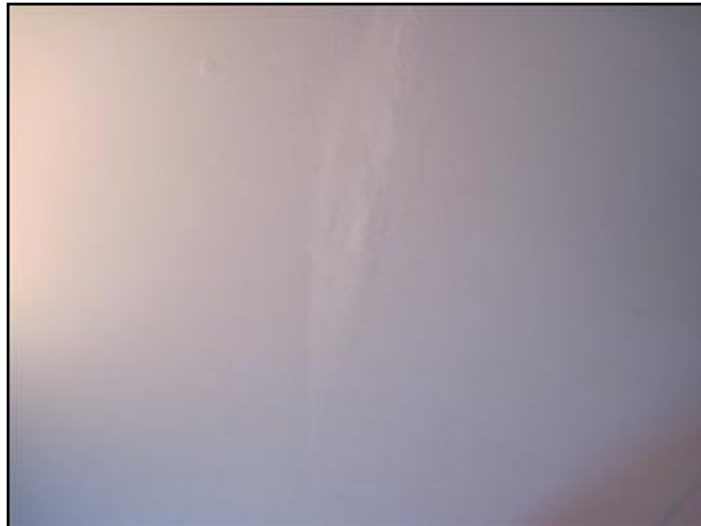
Observed a crack in the kitchen ceiling of 5093. The has been patched but is still visible.

Tested the area with a GE Protimeter Surveymaster moisture detector and did not find any presence of moisture.

*Crack visible in kitchen ceiling*

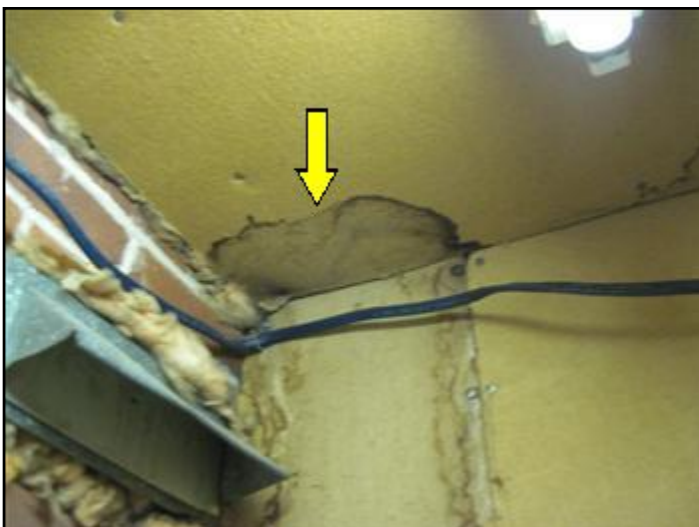
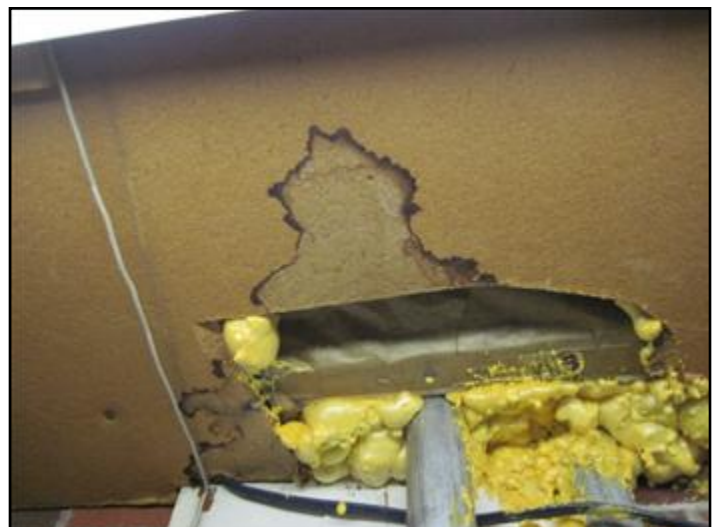
Observed water stains on the ceiling fibreboard in the utility room of unit 5093.

Tested for moisture and the covering was dry indicating this may have been from a previous water infiltration problem.

Water stain utility room 5093

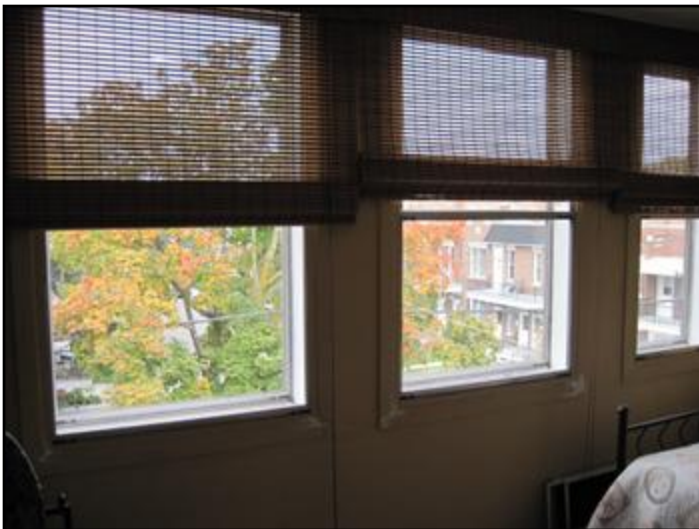
Observed several windows sealed with silicone to help reduce air infiltration in units 5091 and 5093.

*Series of windows sealed with silicone*

The units are lower quality aluminum type and should be replaced for improved ease of operation and energy efficiency.

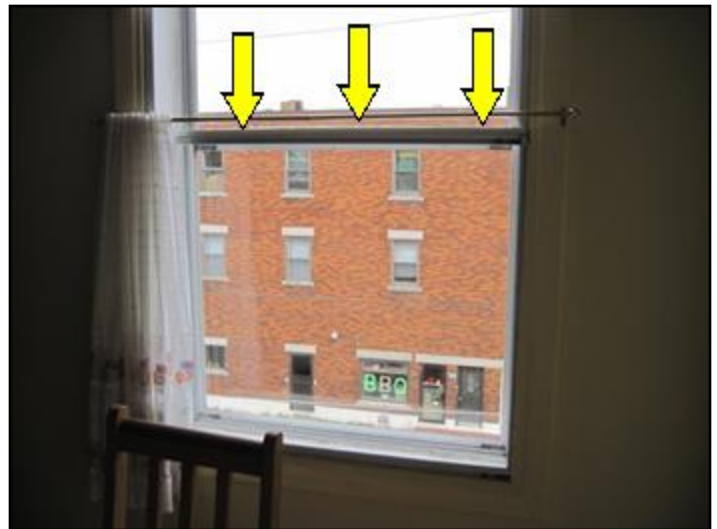
*Window sealed with silicone*

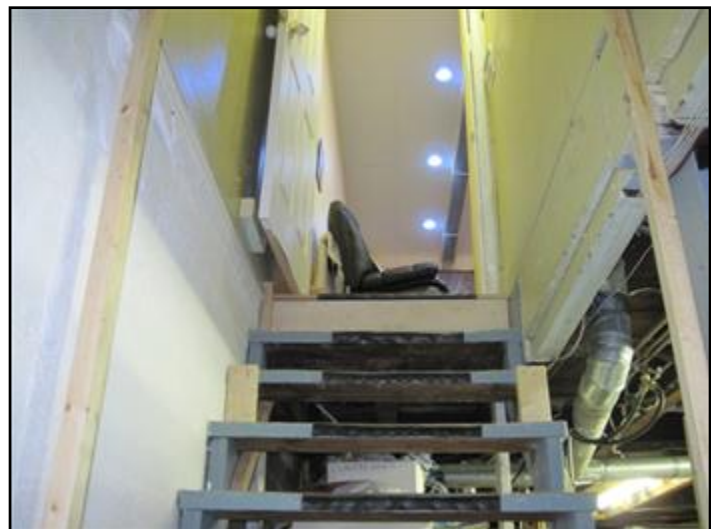
Noted the absence of a handrail in the staircase leading to the basement from unit 5089.

Handrail missing in staircase

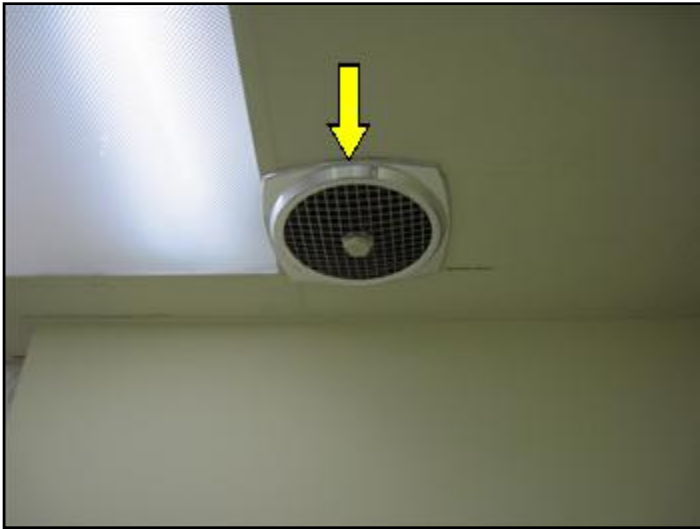
Noted the presence and verified the operation of the bathroom exhaust fans for units 5091 and 5093, however did not see or find the termination point for the exhaust of these devices on the exterior of the building.

*Bathroom exhaust fan 5093*

Recommend further evaluation or disclosure from the seller.

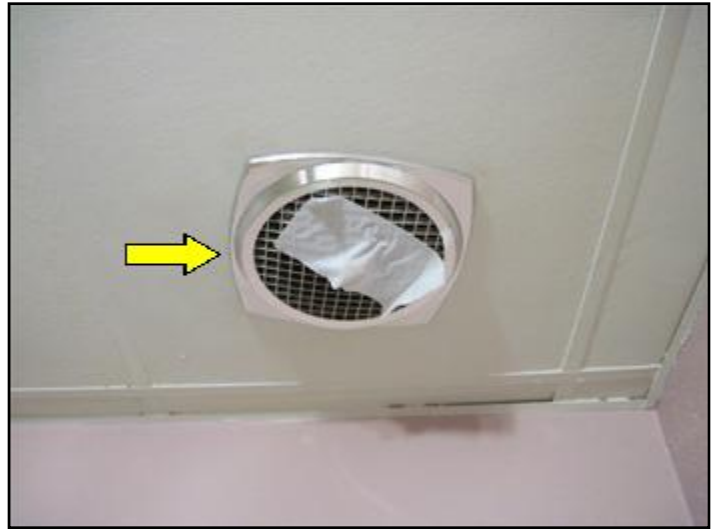
*Bathroom exhaust fan 5091*

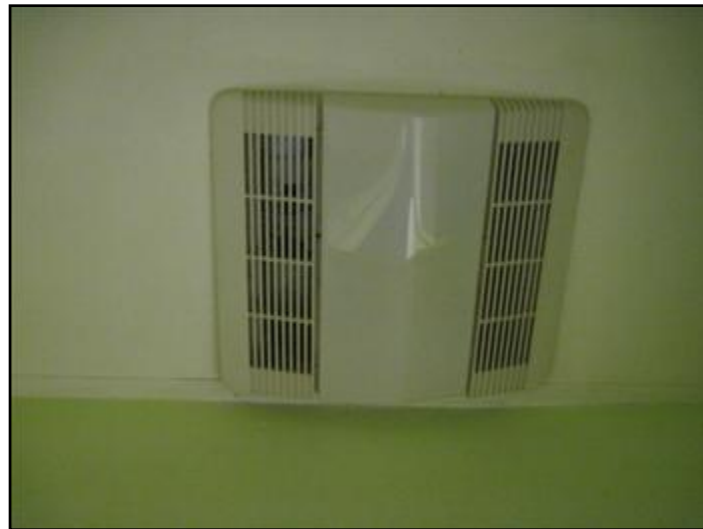
*Bathroom fan not functional in 5089*

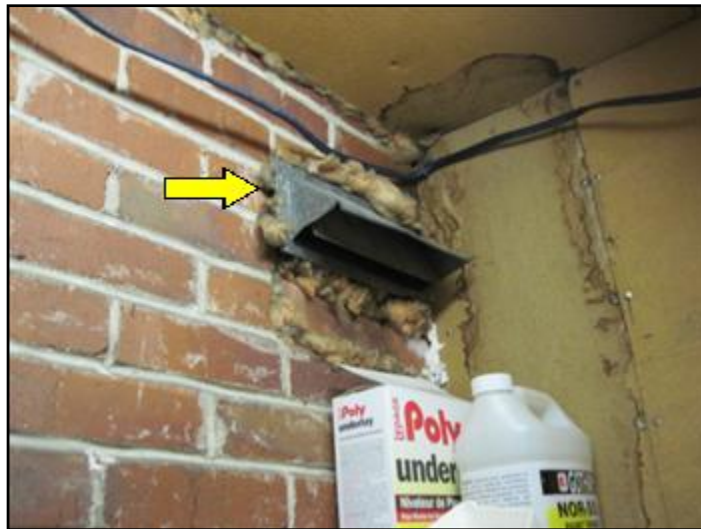
Noted the range hood exhaust for 5093 is venting into the rear utility room.

This is not recommended since moisture laden air is being sent into a cool space where the moisture will tend to condense on the cold surfaces.

Range hood exhaust for 5093

Recommend extending the duct to vent outside.

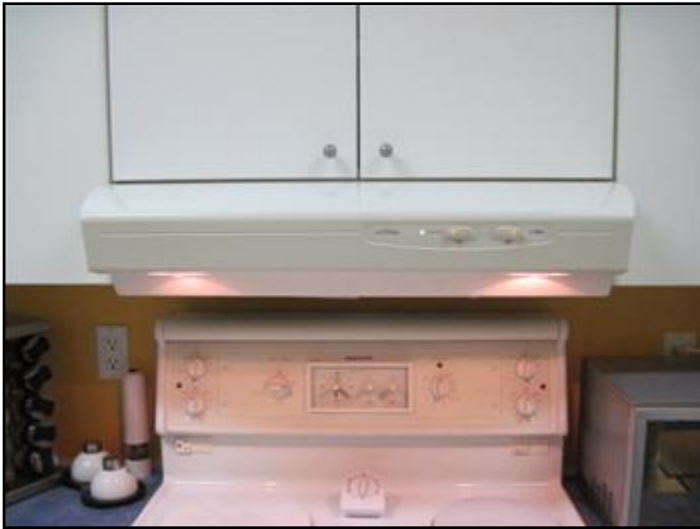
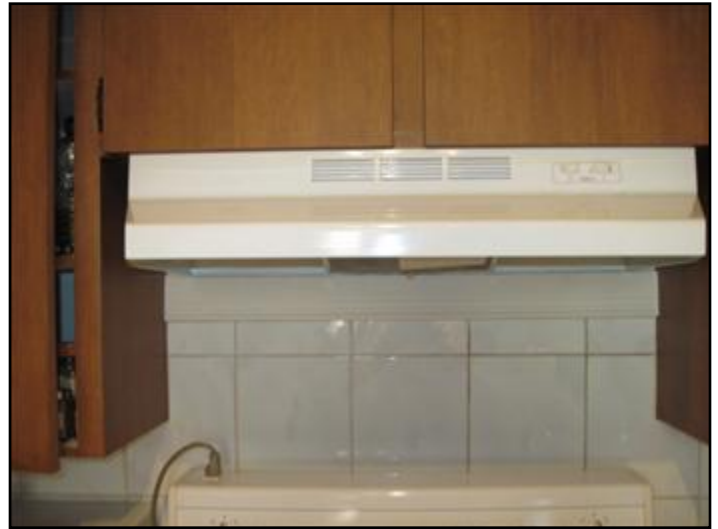
Noted the kitchen exhaust systems in units 5089 and 4091 are not vented to the exterior. This is a recommended improvement.

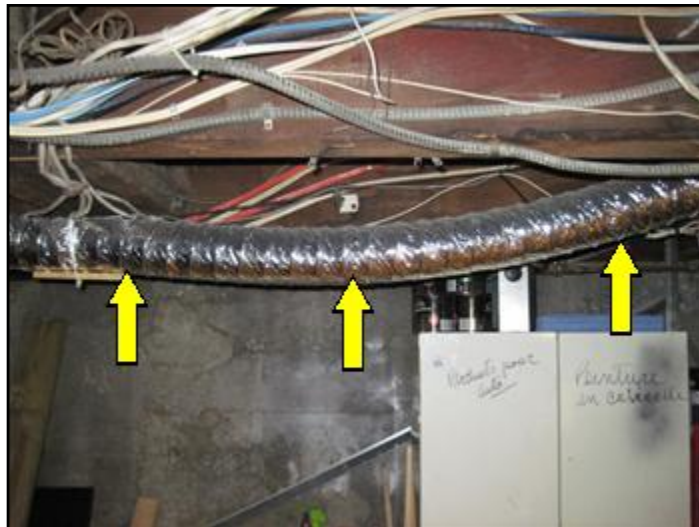
**Condition:** • The flexible conduit pipe for the dryer should be replaced with rigid galvanized steel pipe to reduce lint build up, air flow resistance and risk of fire.

Flexible pipe for dryer in basement
