Your Inspection Report

2551 St-Denis
Montreal, QC

INSPECTION DATE:
Thursday, November 5, 2009

RE: Report No. 1170, v.2
2551 St-Denis
Montreal, QC

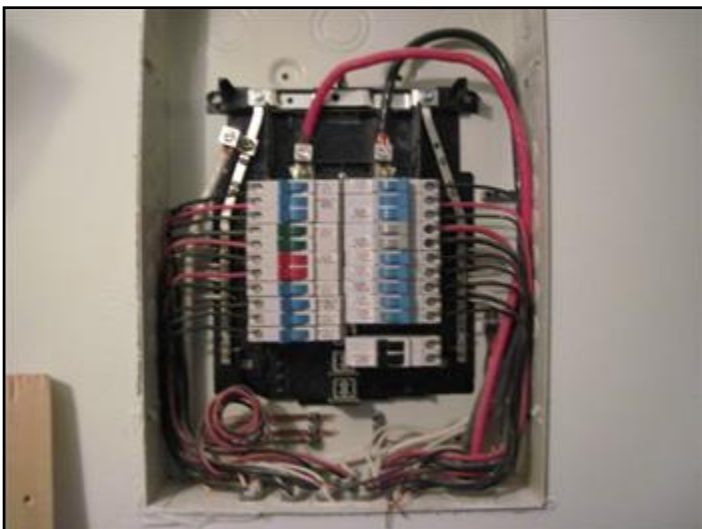
We did observe one breaker installed that is not in service and one set of wires that is not connected. These are possibly optional installations provided for other potential uses.

View inside electrical panel

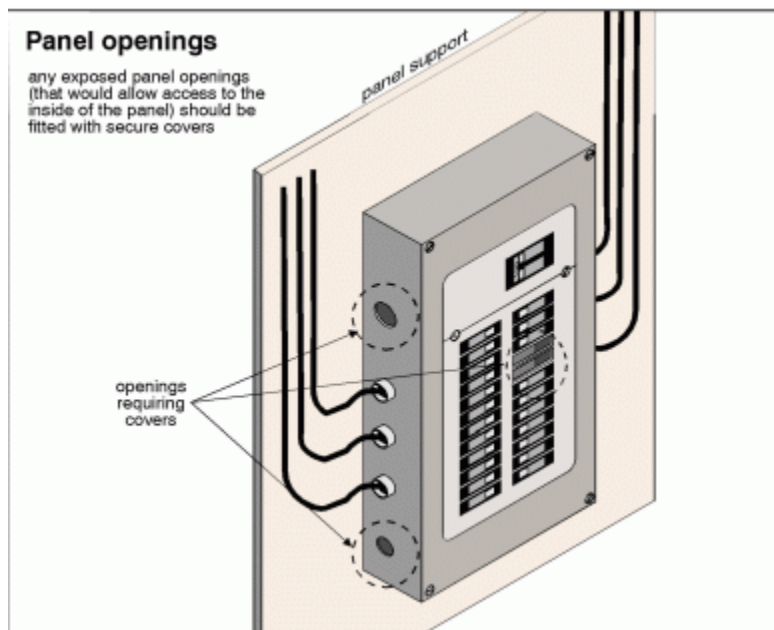
Condition: • [Openings in panel](#)

We observed some openings in the electrical panel cover where the normal plastic covers are missing. These should be covered as a safety measure since the main bus bars inside carry high electrical amperage.

Implication(s): Electric shock | Fire hazard

Task: Correct

Time: Immediate

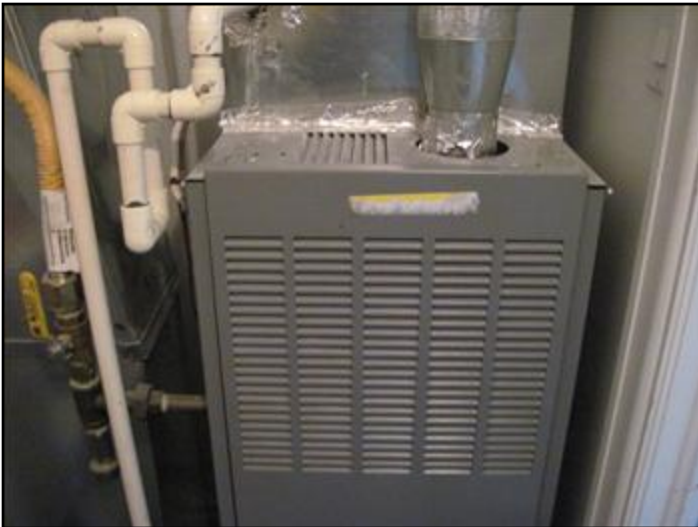
The unit was tested and the exhaust fan for combustion gases operated normally as well as the burners and air circulation system.

No defects or anomalies visible.

Gas fired forced air furnace

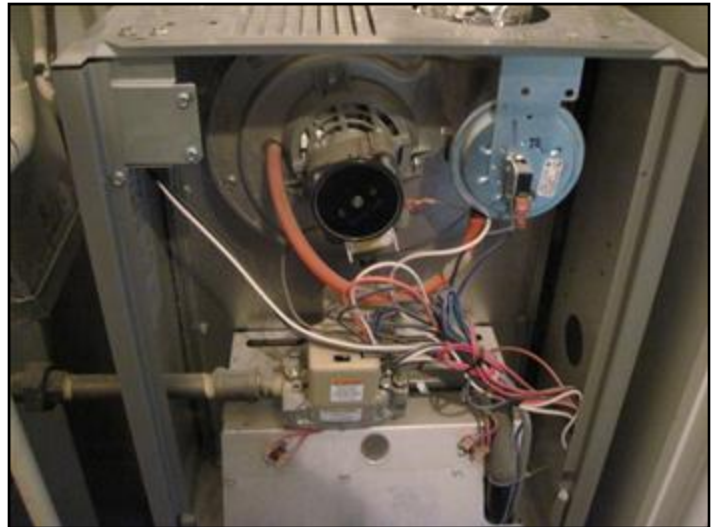
View of blower and burner chamber

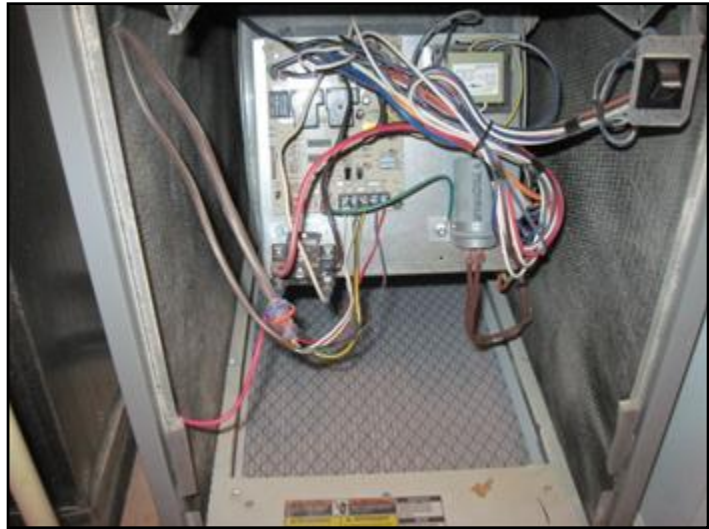
View of air blower and filter chamber

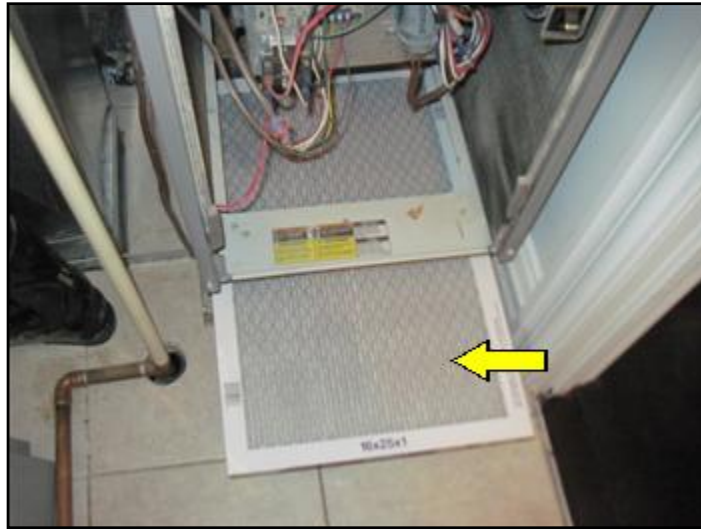
Condition: • The furnace is currently installed with a high efficiency disposable air filter.

The filter is relatively new and clean and should be replaced every three months for optimal performance.

3M Filtrete High Performance Air Filter

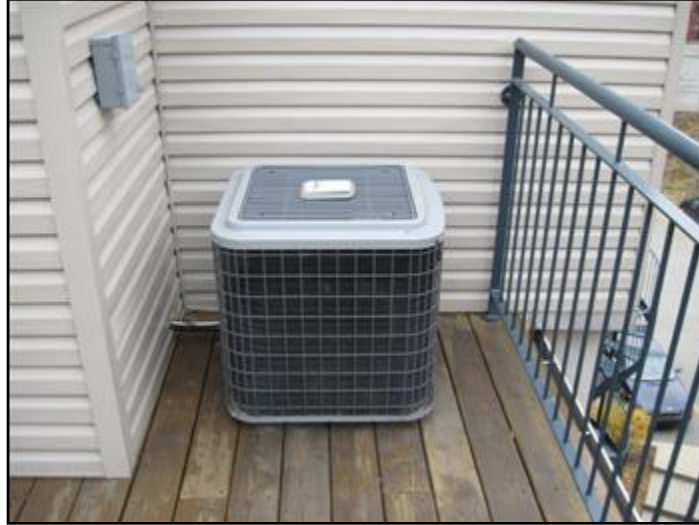
AC condenser unit on rear exterior deck

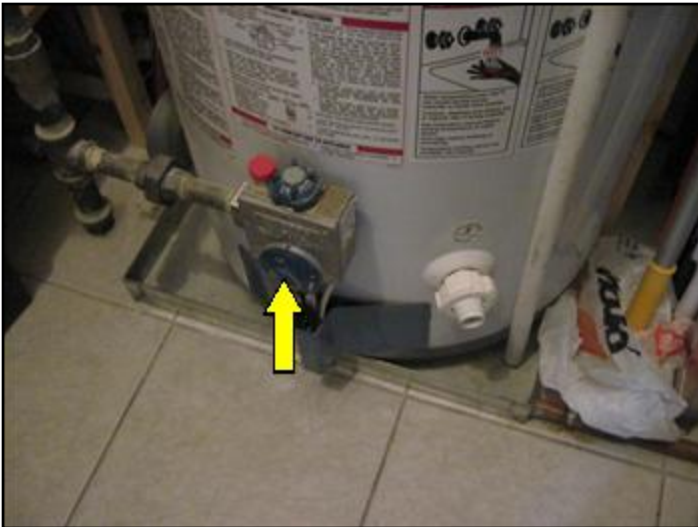
Water heater temperature control

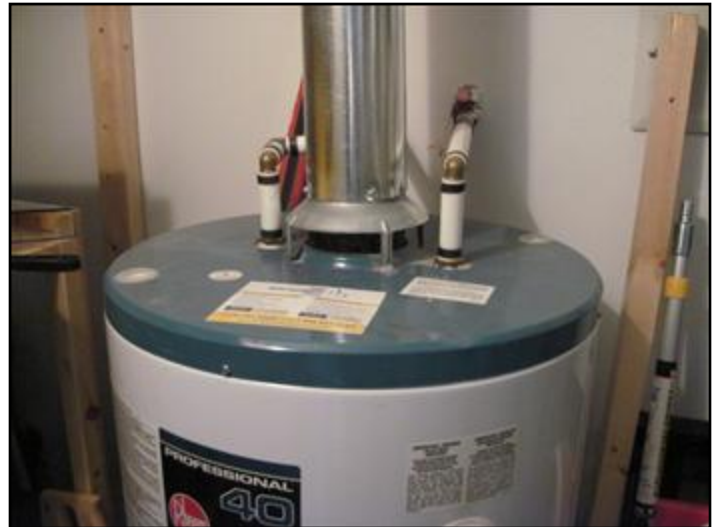
Gas fired water heater in utility room

Water heater type: • The water heater is equipped with required pressure safety release device and tubing.

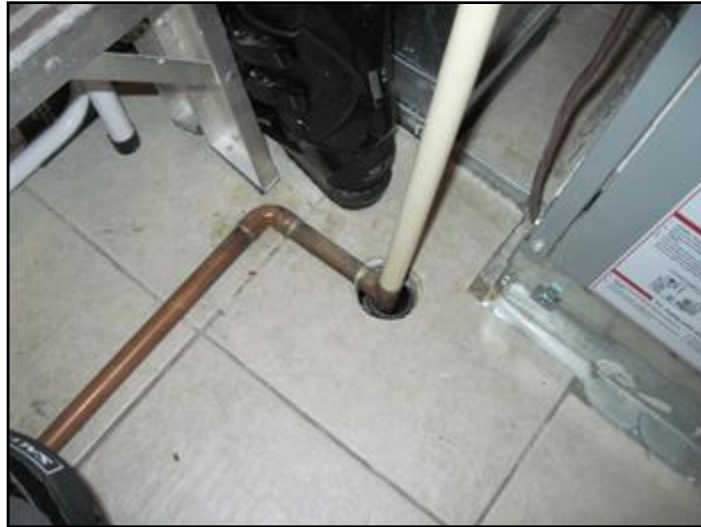
The floor drain is located inside the utility room and is designed to capture any water leakage from the hot water heater as well as condensate coming from the air conditioner evaporator.

Floor drain installed in utility room

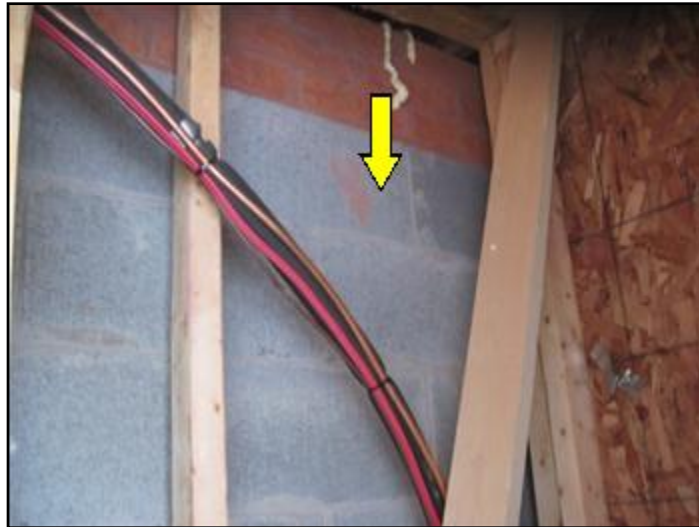
Only a small section of dividing wall was visible at the rear inside a storage compartment.

View of concrete block dividing wall

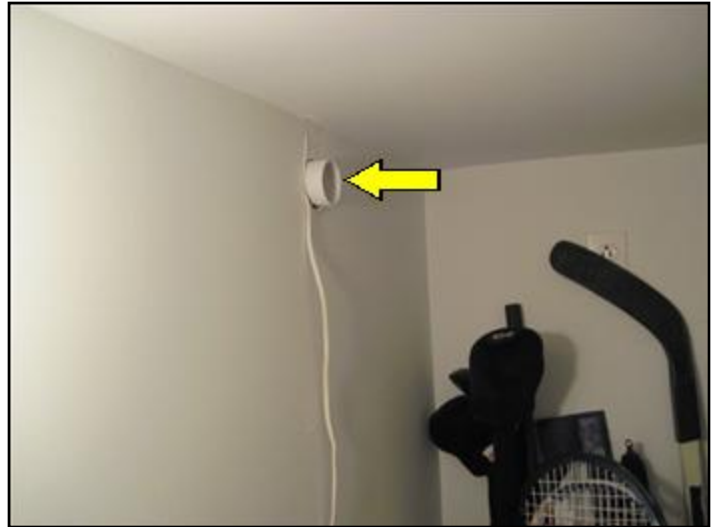
Pipe connection for central vac power unit

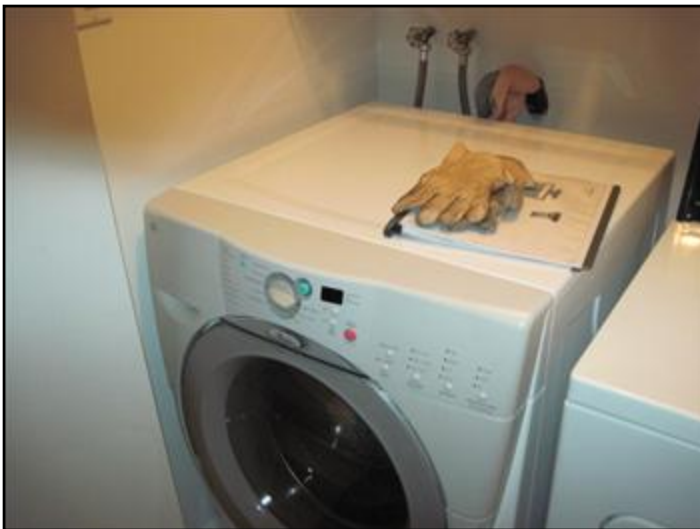
Washer installation

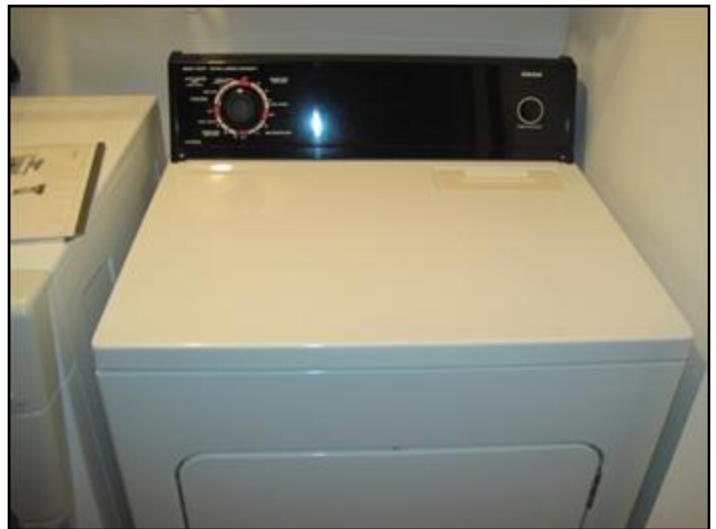
Dryer installation
