Your Inspection Report

1252 King Avenue
Cote St-Luc, QC

INSPECTION DATE:
Friday, October 30, 2009

RE: Report No. 1168, v.4
1252 King Avenue
Cote St-Luc, QC

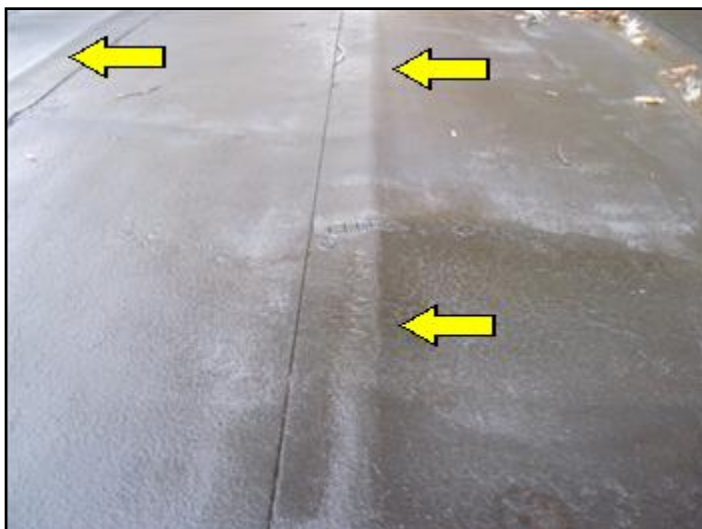
Ridging visible

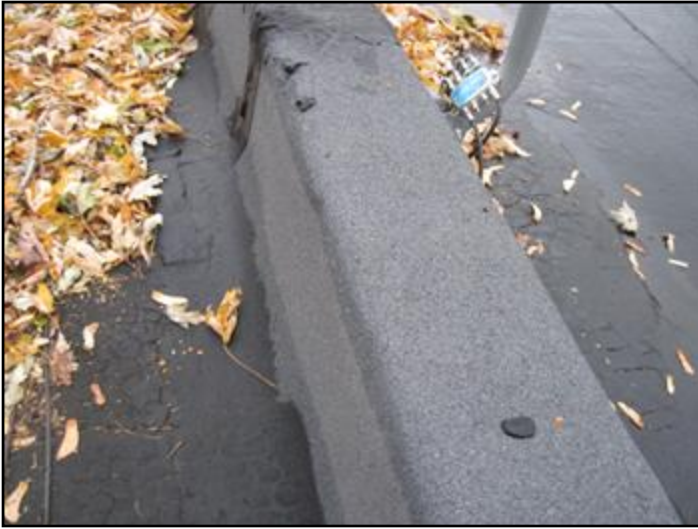
The portion of membrane that has not been coated suggests the original membrane is modified bitumen with ceramic granules too protect against UV damage.

View of membrane without coating

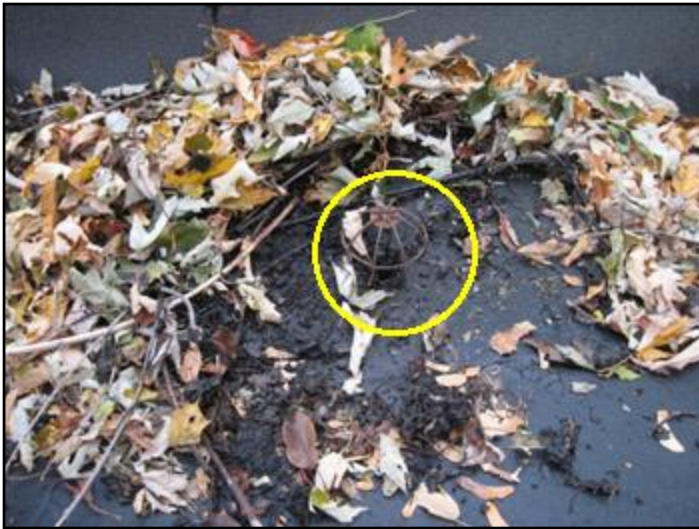
Clogged roof drain

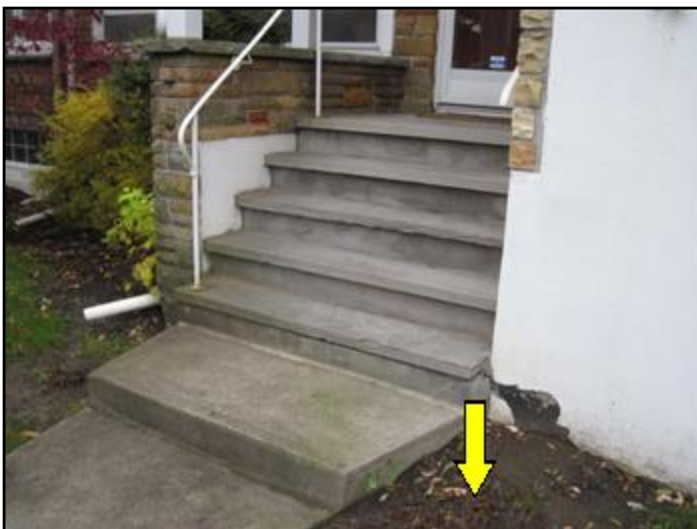
Right corner has settled

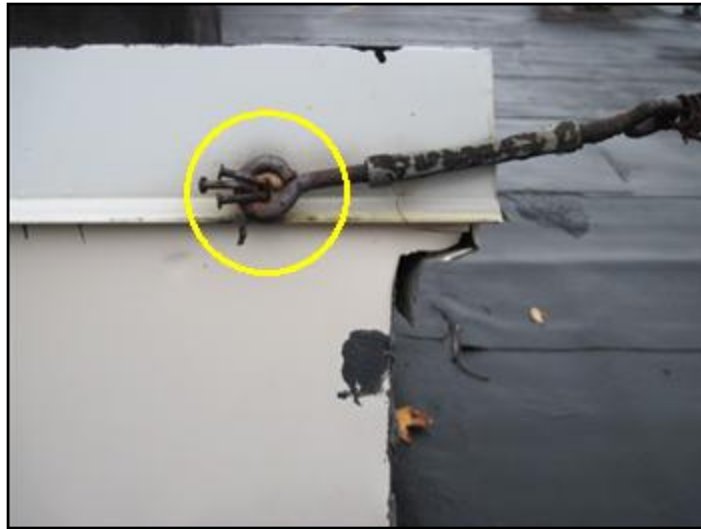
Condition: • Observed the installation of a steel cable attached to the mast to help support the weight and tension of the electrical cable from across the street.

The steel cable is corroded and its attachment should be monitored and improved as necessary.

Cable attachment to roof

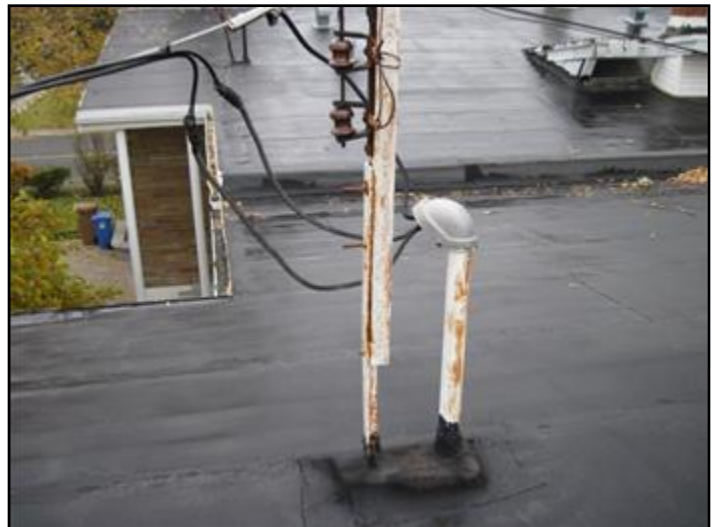
Suspect there may have been water infiltration from the masthead on the roof inside the conduit at some point.

The current installation did not reveal any abnormalities with the roof installation that would contribute to water infiltration.

Masthead visible on roof

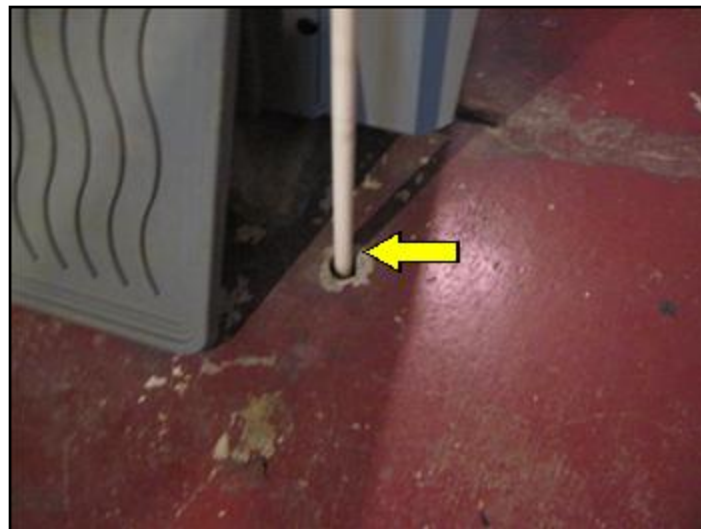
Observed the evaporator condensate drain line is discharging into a hole made in the concrete floor slab.

This is not recommended as it can cause unwanted excess humidity in the basement and create other problems.

Condensate line discharge point

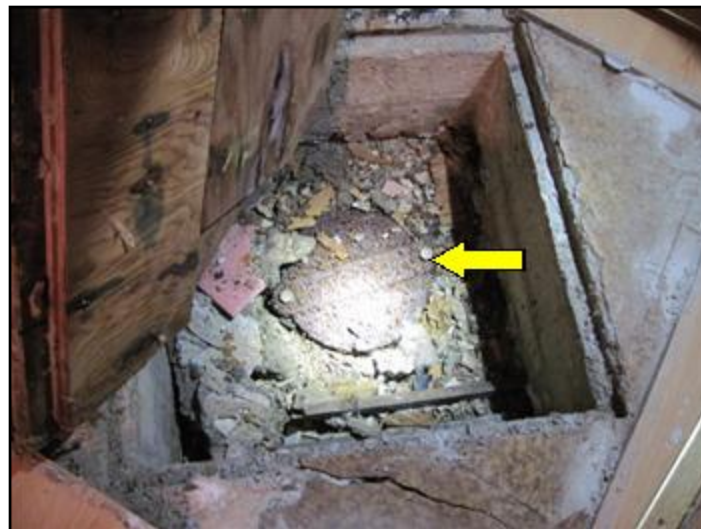
Sewer backflow prevention device

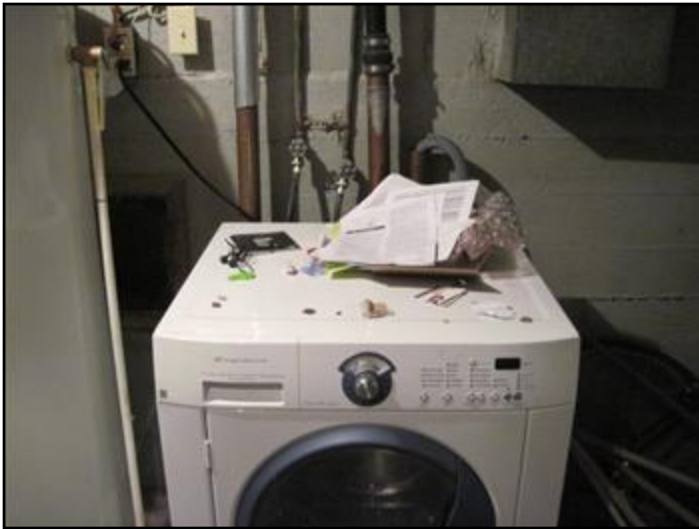
Washer installation

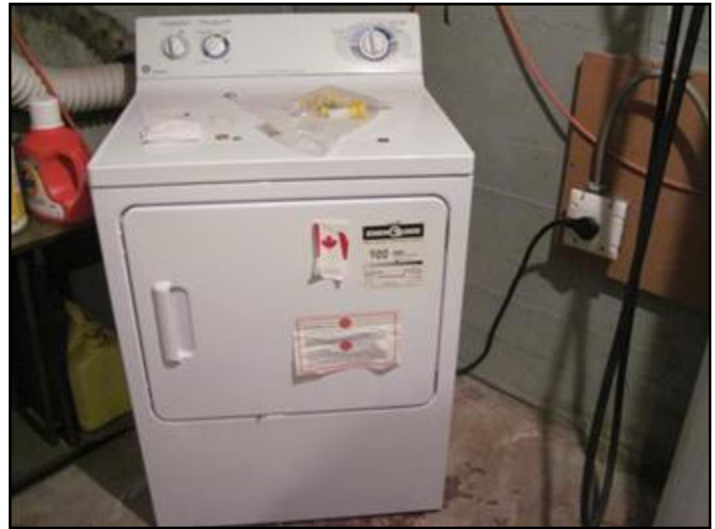
Dryer installation

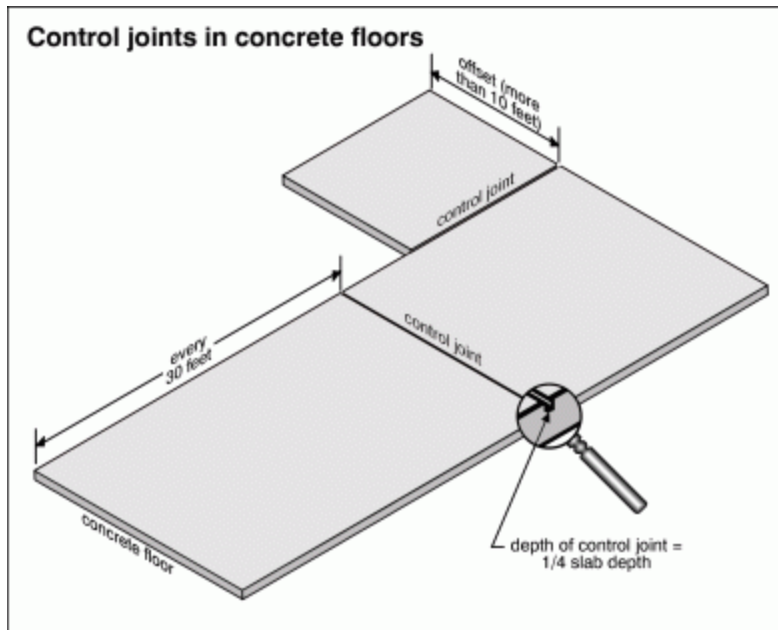
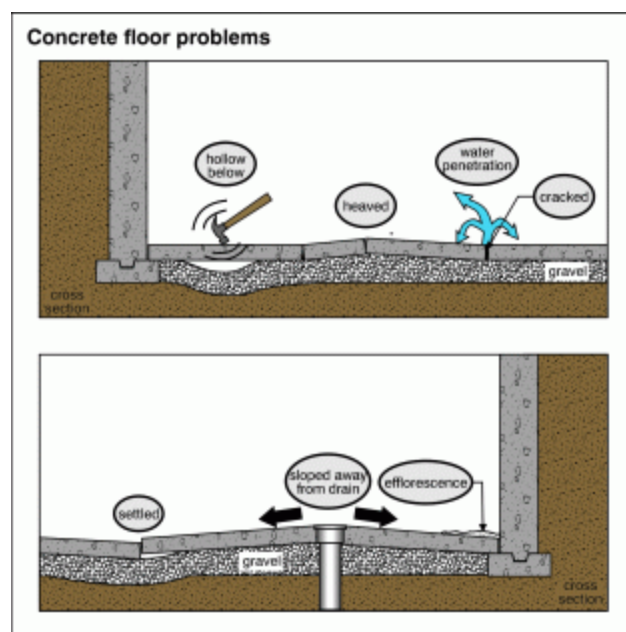
Observed several cracks in the garage floor slab.

These appear to be mostly settlement cracks and there is not enough evidence to suggest a pyrite test is required.

Cracks in garage floor slab

Task: Monitor

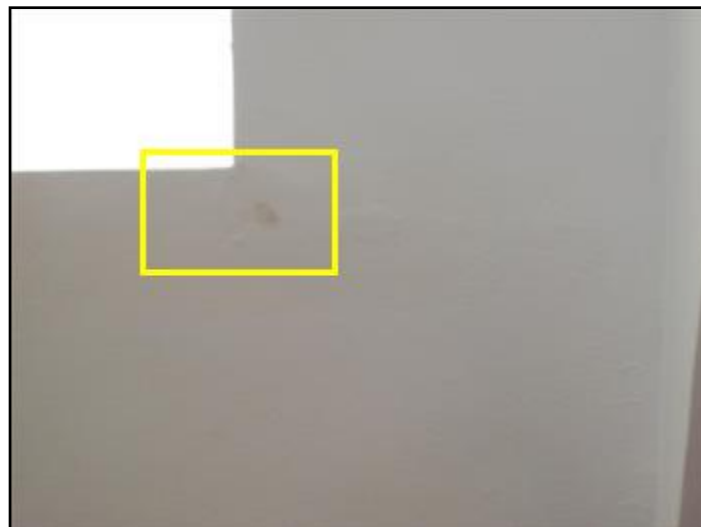
Observed what appears to have been water infiltration and repairs performed under a skylight.

A test of the area using a GE Protimeter Surveymaster moisture sensor revealed no presence of moisture at the time of inspection.

Area tested for moisture

Task: Monitor

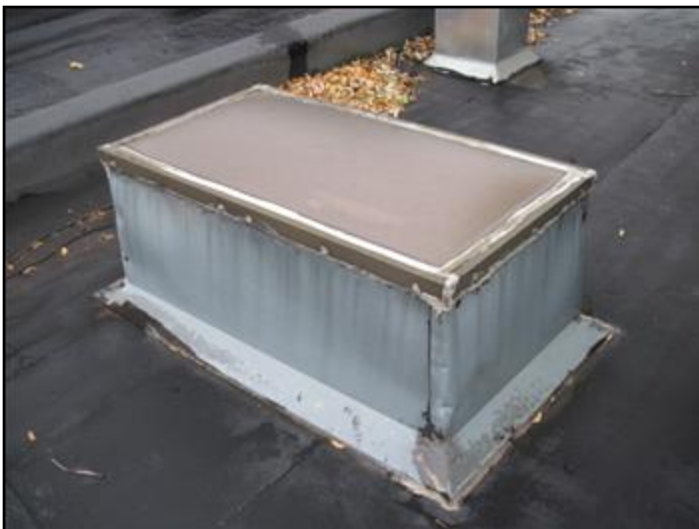
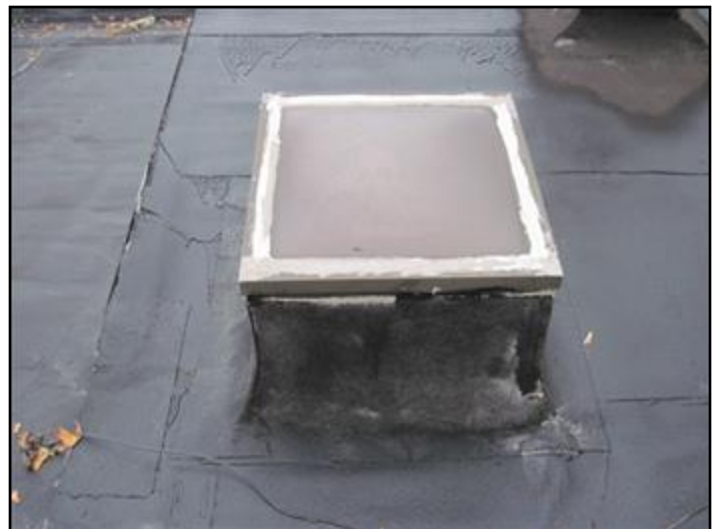
Condition: • Observed the presence of condensation inside the skylight glazing suggesting the units have lost their hermetic seal.

The skylights are old and due for replacement.

Skylight seen from rooftop

Task: Replace

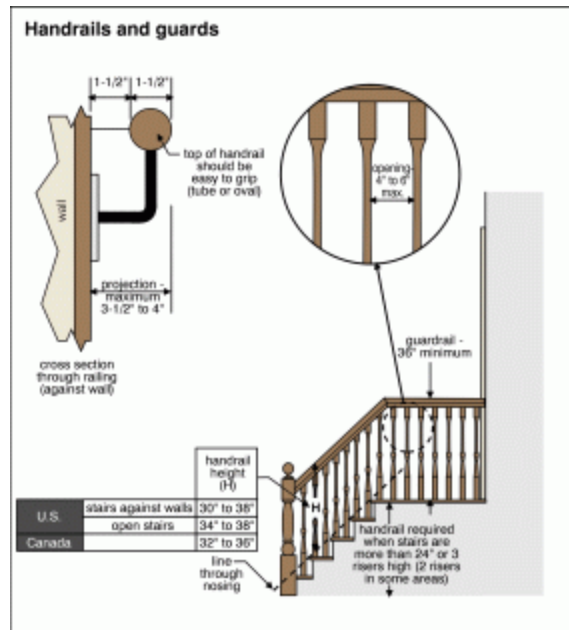
Noted a handrail is missing in one of the basement staircases.

Implication(s): Fall hazard

Handrail missing

Task: Provide

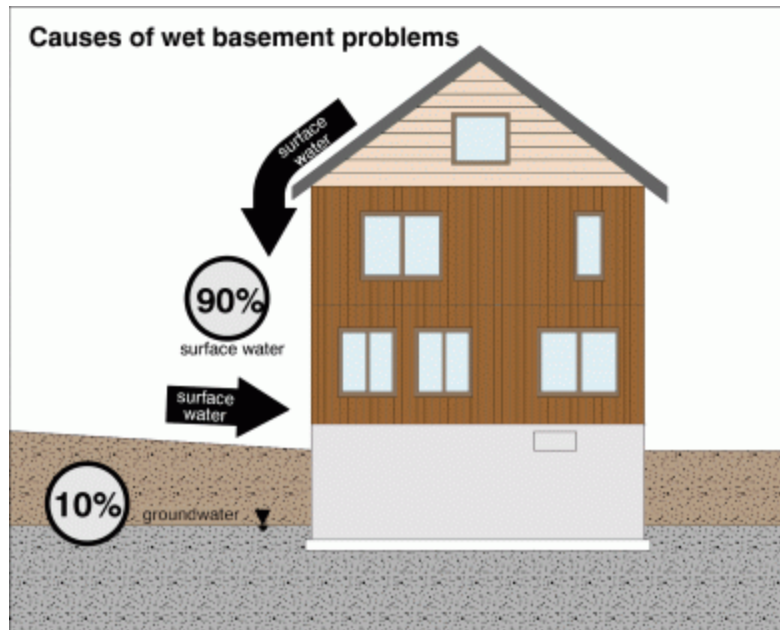
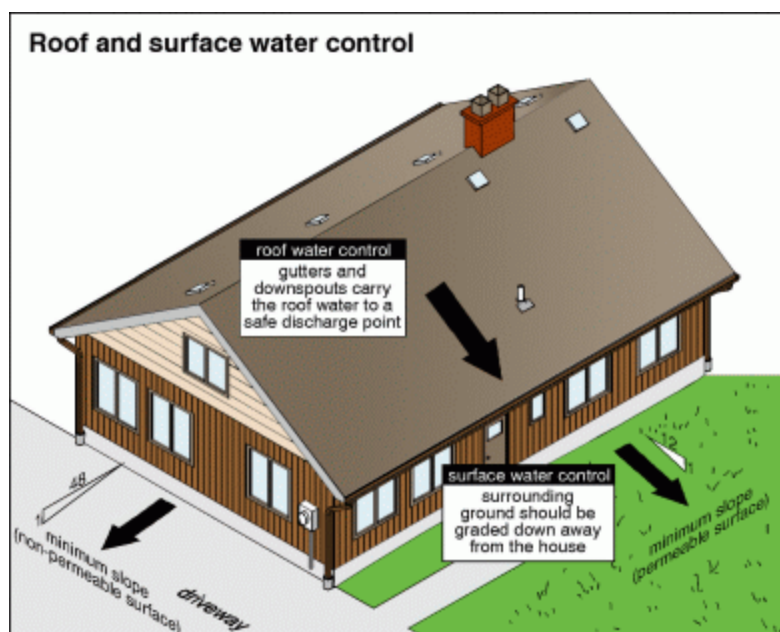
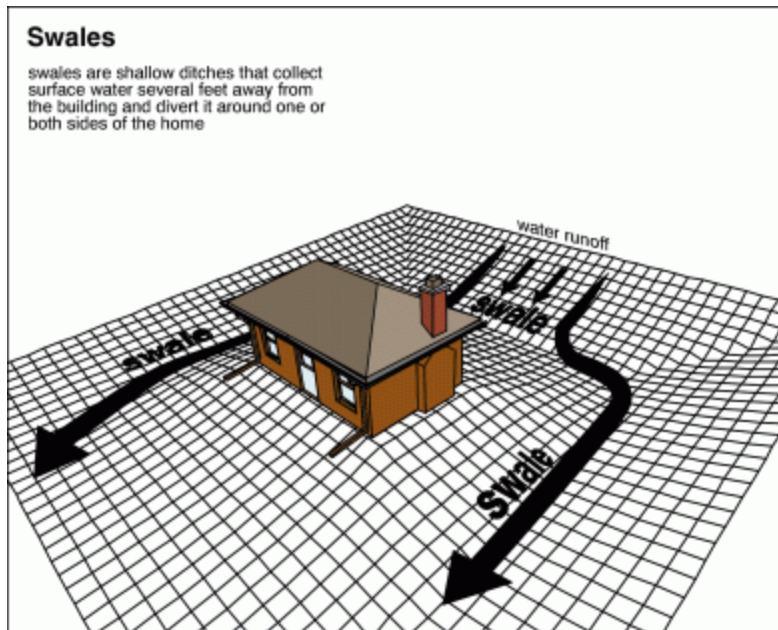
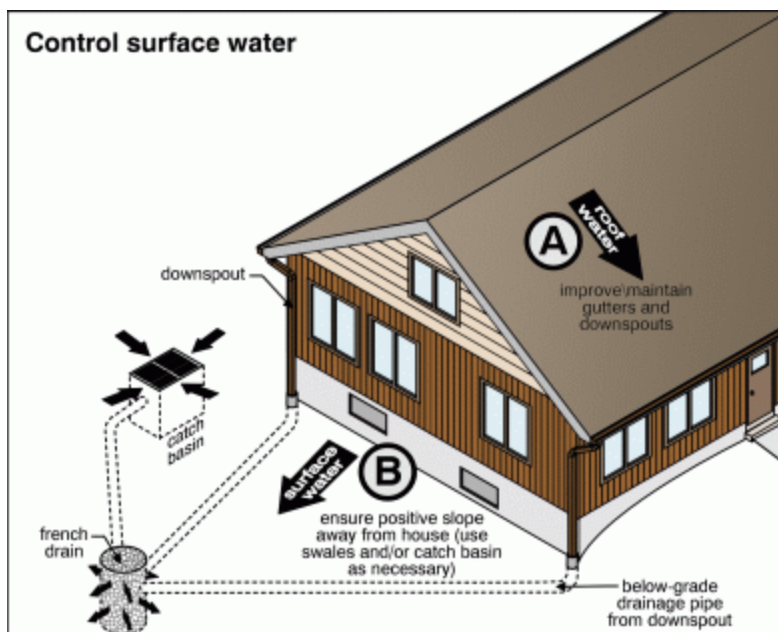
Condition: • [Poor grading](#)

Since the house basement is finished it is extremely important to keep water away from the foundations.

Implication(s): Chance of water damage to contents, finishes and/or structure

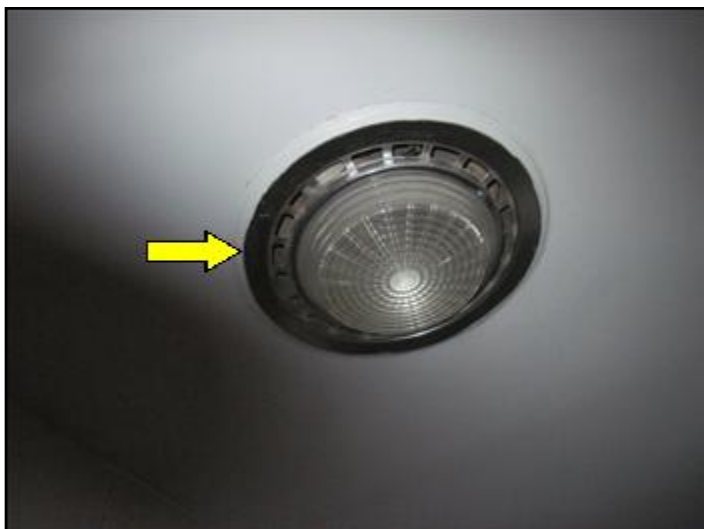
Noted exhaust fans installed in the bathrooms but no clear exhaust point to the exterior.

Main bathroom exhaust fan

Further examination should be undertaken to ensure interior air is not being vented into a cavity where damage can be caused from condensation.

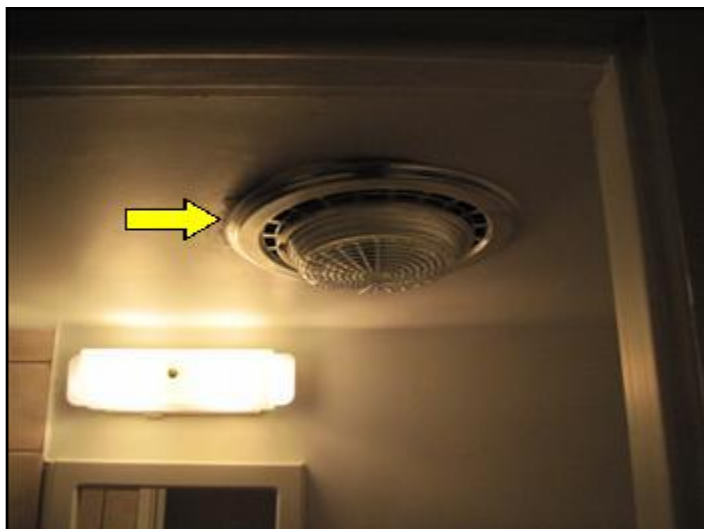
Basement bathroom exhaust fan
